**ENGINE NO START IN EXTREMELY COLD AMBIENT TEMPERATURES**

**Bulletin No:** 01-023/13

2013-2014 CX-5

2014 Mazda6

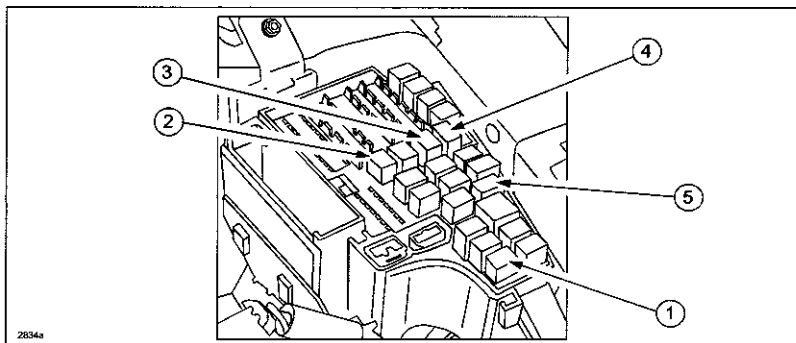
Some vehicles may exhibit an engine no start in ambient temperatures below -4 degree Fahrenheit (-20 degree Celsius) after driving for 10 - 20 minutes and then parking the car for about one hour. This may be caused by the contact point of the main relay freezing due to moisture inside the main relay.

1. Verify customer concern.
2. Replace the 5 relays shown in the table below.
