Subject: MIL ON WITH DTC P0139	Bulletin No: 01-025/13
	Last Issued: 08/22/2013

2010 Mazda5

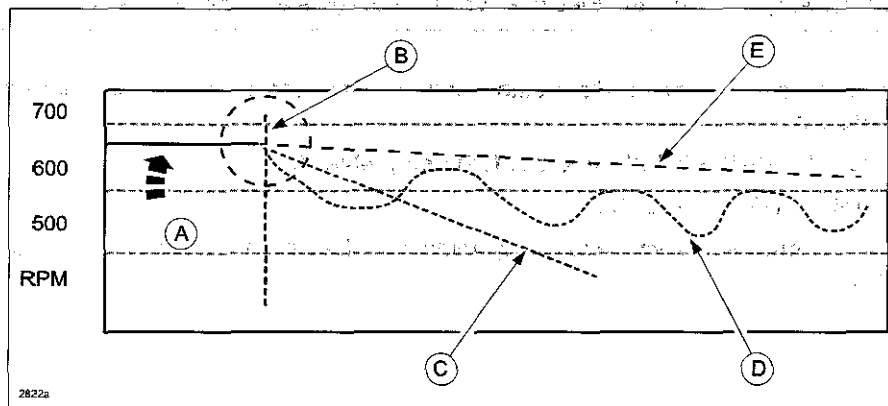
Chart for making decision of carbon accumulation in the throttle body.

- The engine speed drops for more than 100 rpm, or the engine speed is unstable and fluctuates between 500-700 rpm -> The concern is caused by carbon accumulation in the throttle body. Clean the throttle body according to the following procedure.
 - The engine speed is stable within the specification -> The concern is not caused by carbon accumulation in the throttle body. Diagnosis for other concerns according to the Workshop Manual.

A	Engine at idle (warmed-up with no loads)
B	Start of test mode
C	Sample 1: No Good - RPM decreases
D	Sample 2: No Good - RPM is unstable
E	Sample 3: Good - RPM is within spec
