Service Bulletin

Subject: MIL ILLUMINATION WITH DTCs P219A:00 AND/OR P219B:00	Bulletin No: 01-027/13
	Last Issued: 10/31/2013

2011-2013 CX-9

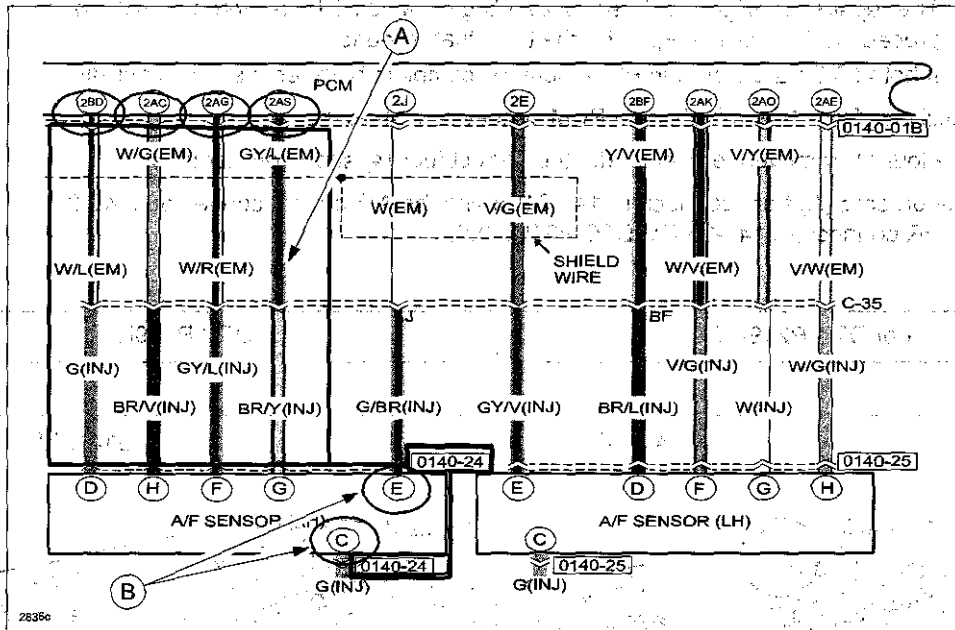
Wiring Diagram:

(A) = Install short cord

(B) = A/F Sensor (RH) terminals C and E

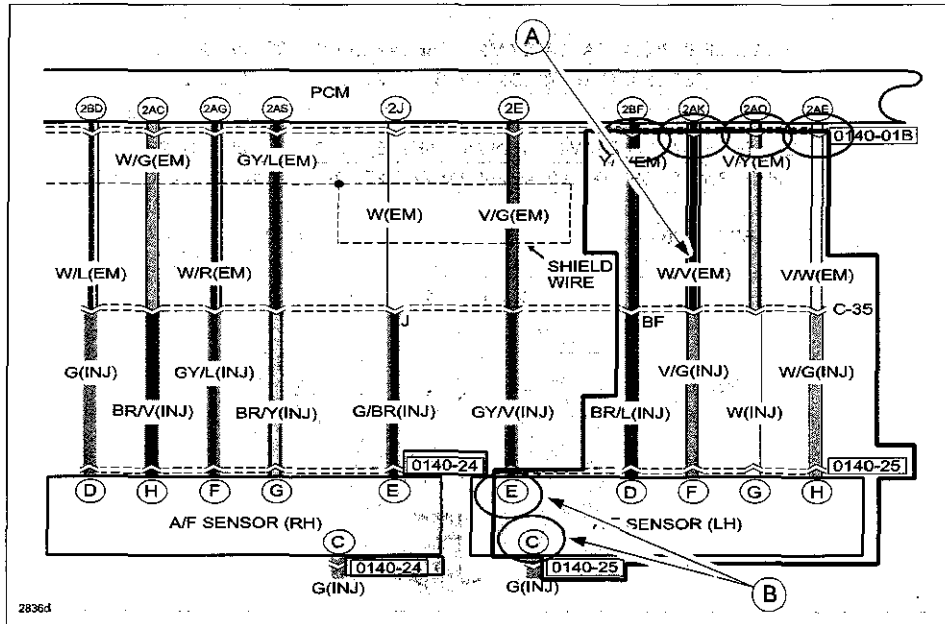
Wiring Diagram:

(A) = Install short cord

(B) = A/F Sensor (LH) terminals C and E
