Service Bulletin

Subject: MIL ILLUMINATION WITH DTCs P219A:00 AND/OR P219B:00	Bulletin No: 01-027/13
	Last Issued: 11/12/2013

2011-2013 CX-9

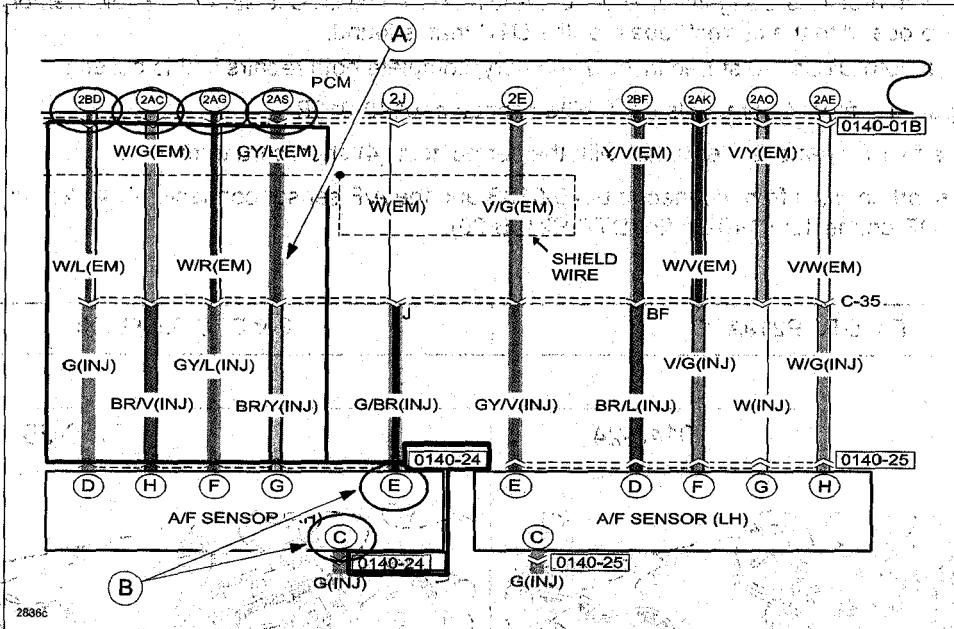
(A) = Install short cord

(B) = A/F Sensor (RH) terminals C and E

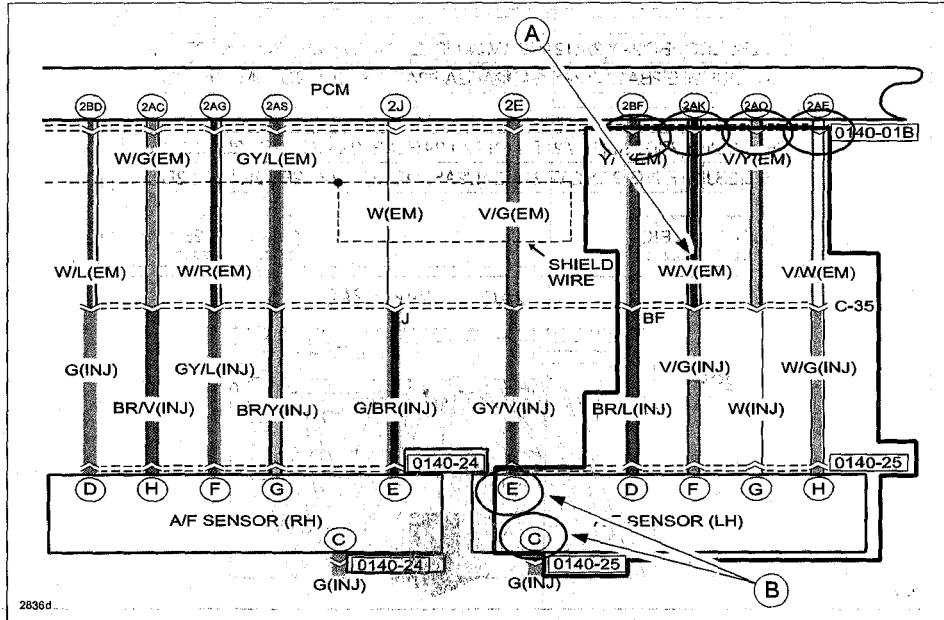
(A) = Install short cord

(B) = A/F Sensor (LH) terminals C and E
