Subject: "i-ELOOP INSPECTION REQUIRED" IS DISPLAYED IN THE INSTRUMENT CLUSTER INFORMATION DISPLAY	Bulletin No: 01-028/13
	Last Issued: 11/19/2013

2014 Mazda6

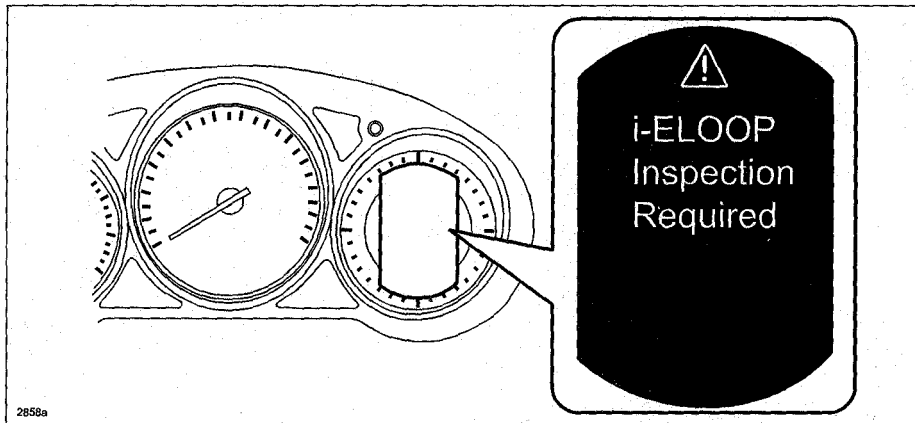
Some customers may experience a warning message "i-ELOOP Inspection Required" in the instrument cluster information display while driving. The master warning light will also be illuminated. DTC P1794:00 (Capacitor (i-ELOOP) system: Capacitor (i-ELOOP) malfunction) is stored in PCM memory.

1. Verify DTC P1794:00 is stored in PCM memory.
2. Select M-MDS initial screen > "Datalogger" > "Module" > "DCDC" > PID "CAP_SYS_16" and read the value.
3. Does the "CAP_SYS_16" show ON?
 - Yes - Proceed to step 4.
 - No - This service bulletin does not apply. Refer to MS3 online or Workshop Manual (section 01-02 DTC P1794:00 [SKYACTIV-G 2.5]).
4. Reboot the IDS to clear memory before reprogramming.

- Using IDS 87.04 or later software, reprogram the PCM to the latest calibration following the "Module Reprogramming" procedure.
