Service Bulletin

Subject: INFORMATION DISPLAY SHOWS "FOW INSPECTION REQUIRED" AND DTC C1A67:78 IS STORED	Bulletin No: 01-029/13
	Last issued: 11/27/2013

2014 Mazda6 vehicles with VINs lower than JM1 GJ ***** 149082 (produced before October 01, 2013)

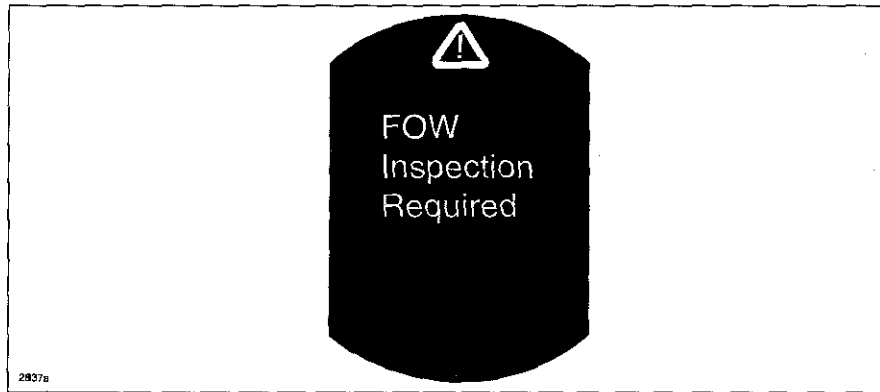
Some customers may experience a MRCC malfunction when driving long distances with MRCC set. Instrument cluster information display shows "FOW INSPECTION REQUIRED" and DTC C1A67:78 (Radar sensor axis is deviated) is stored. This is caused by MRCC no obstacle detection during a long drive.

Customers having this concern should have their vehicle repaired using the following repair procedure.
