Subject: KNOCKING / SQUEAKING NOISE FROM FRONT STRUT BEARING	Bulletin No: 02-005/13
	Last Issued: 11/11/2013

2013-2014 CX-5 vehicles with VINs lower than JM3KE*****343674 (Produced before April 16, 2013)

2014 Mazda6 vehicles with VINs lower than JM1GJ*****121430 (Produced before April 16, 2013)

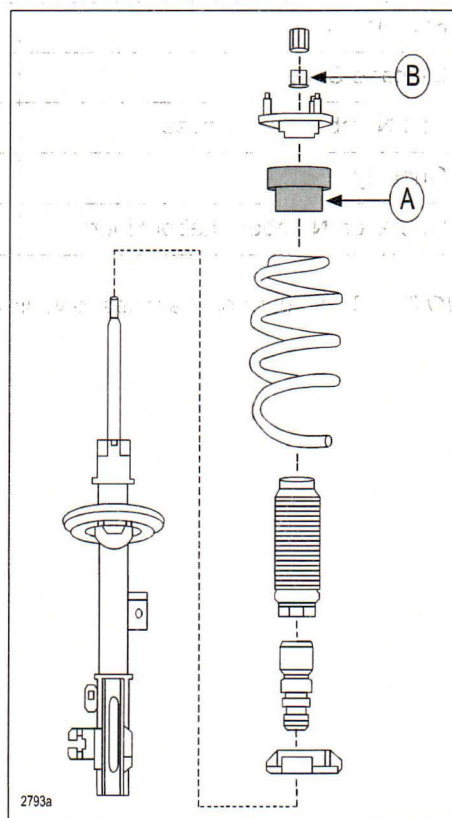
2793a

Some vehicles may exhibit a knocking / squeaking noise from the front strut bearing (A) due to front strut bearing damage when driving on rough roads and/or when turning the steering wheel while the vehicle is stopped.

The noise may be due to the upper housing of the front strut bearing being damaged when applying excessive force to the bearing during customer use. To eliminate the noise, the material and production method of the front strut bearing has been changed.

NOTE: The piston rod nut (B) requires replacement when the front strut bearing is replaced.

5. Using ChassisEAR SST, is the noise is coming from the upper part of front shock absorber?
 - Yes - Proceed to step 6.
 - No - This bulletin does not apply.
6. Replace the front strut bearing with a new one according to MS3 online instructions or the Workshop Manual (section 02-13 FRONT SHOCK ABSORBER AND COIL SPRING DISASSEMBLY/ASSEMBLY).
7. Verify repair.

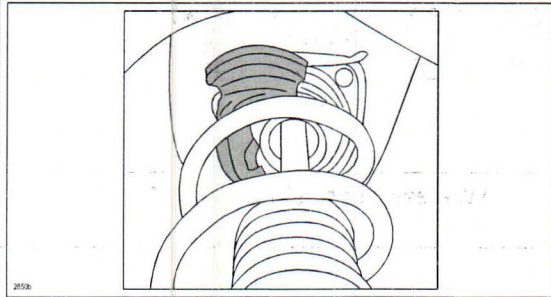
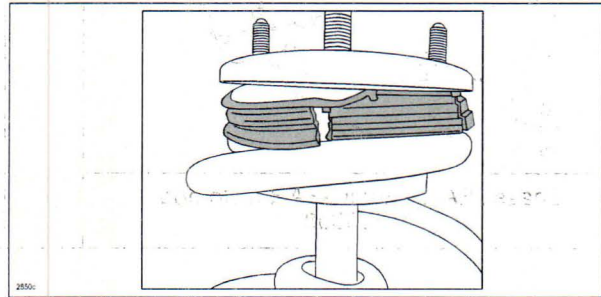
1. Verify customer concern.
2. Is the noise is coming from the upper part of front shock absorber when turning the steering wheel?
 - **Yes - Proceed to step 3.**
 - **No - This bulletin does not apply.**
3. Is the strut bearing broken as shown below?
 - **Yes - Proceed to step 6.**
 - **No - Proceed to step 4.**

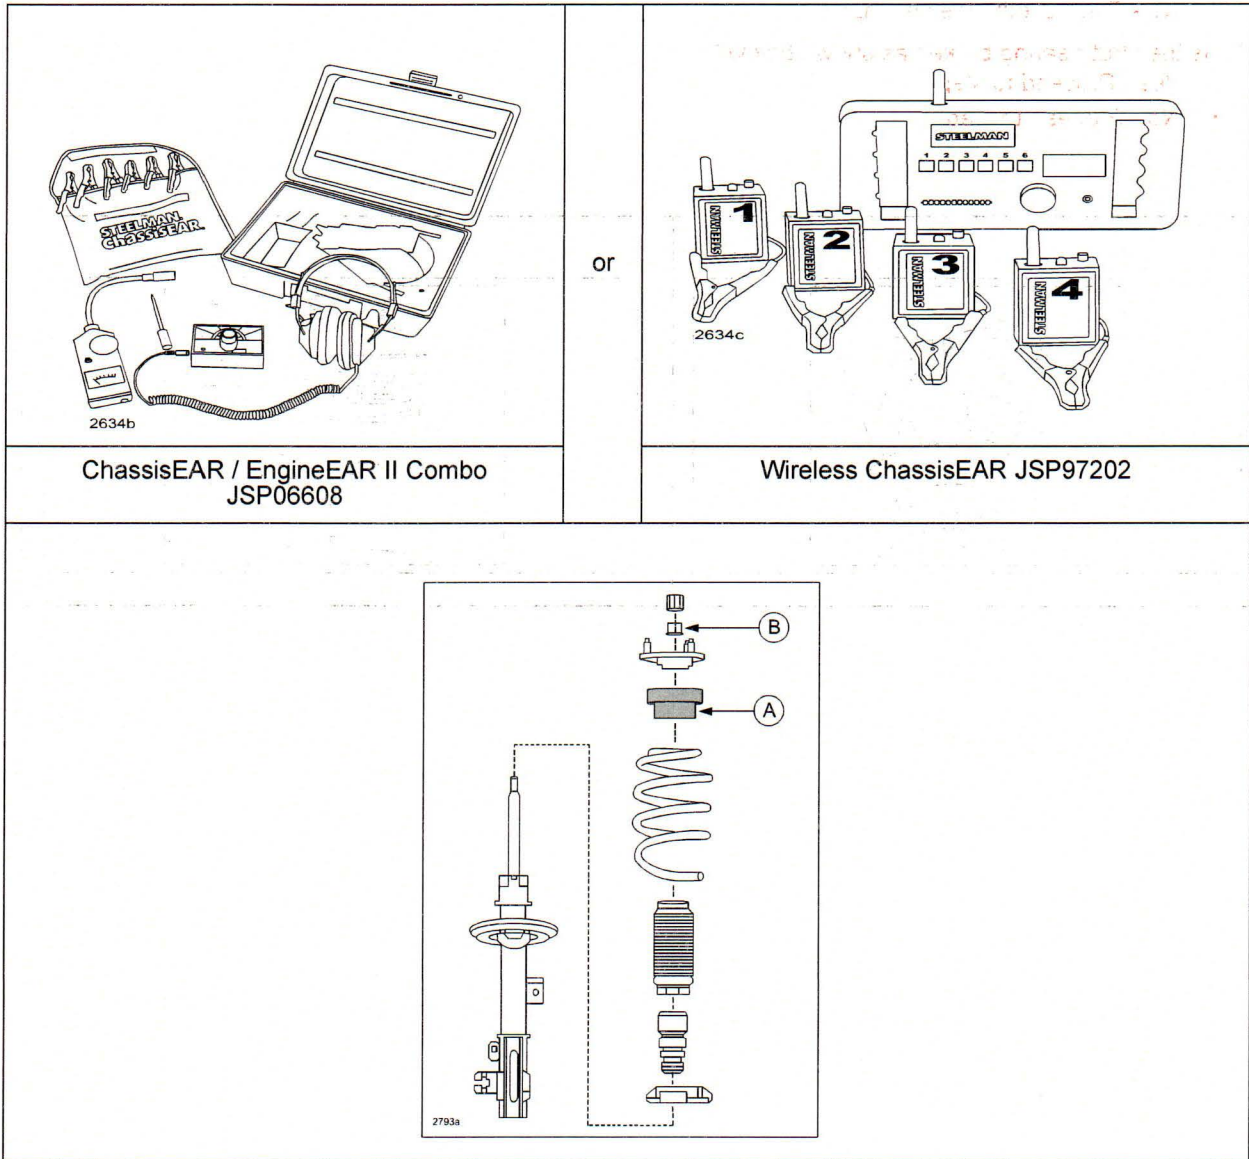
4. Use Special Service Tool (SST) ChassisEAR / EngineEAR II Combo JSP06608 or Wireless ChassisEAR JSP97202 to confirm noise is coming from the upper part of front shock absorber (A) (shown below):
