<b>Subject:</b>  VIBRATION DURING ACCELERATION	<b>Bulletin No:</b> 03-001/13
	<b>Last issued:</b> 01/30/2013

2007-2012 CX-7 4WD vehicles with VINs lower than JM3ER\*\*\*\*\*422257 (produced before Dec. 22, 2011)

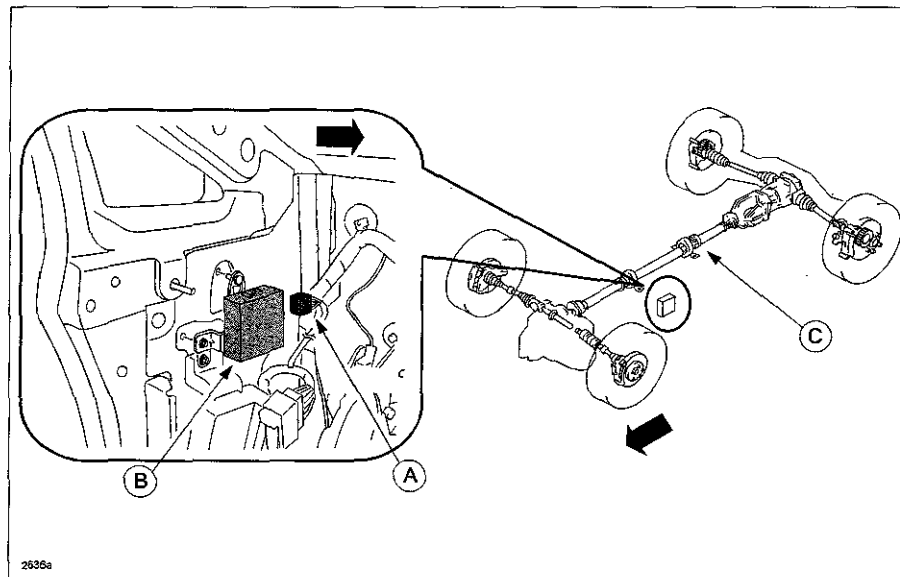
Some customers may notice a vibration from the floor and/or steering wheel during acceleration at approx. 50 mph. To eliminate this concern, the amount of velocity joint grease was increased during mass-production.

1. Before test driving the vehicle, remove the drivers side front scuff plate (inner) and front side trim to gain access to the 4WD control module.
2. Drive the vehicle to confirm the vibration occurs in 4WD.
3. Disconnect the connector (A) for the 4WD control module (B).
