<b>Subject:</b> REPLACEMENT PROCEDURES FOR THE TRANSFER OIL SEALS (RIGHT SIDE)	<b>Bulletin No:</b> 03-002/13
	<b>Last Issued:</b> 03/28/2013

2010-2013 CX-9 equipped with AWD

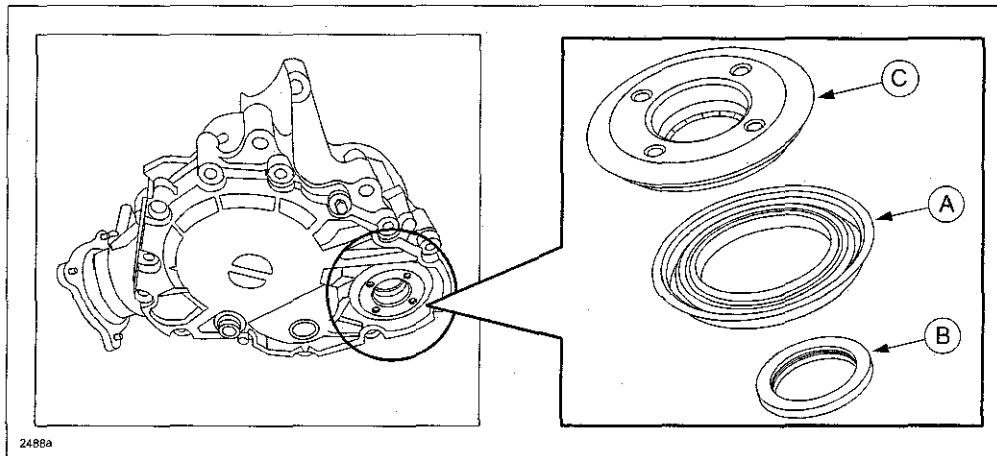
If replacement of the right side (RH) transfer oil seal (A), and transfer dust seal (B) are necessary, use the following REPAIR PROCEDURE to install the new oil seals.

**NOTE:** Deflector (C) may not be reused.

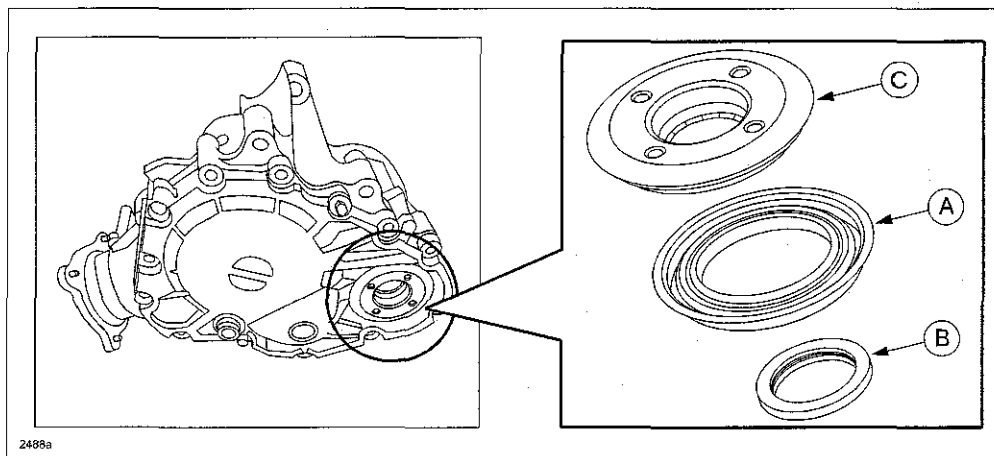
If replacement of the right side (RH) transfer oil seal (A), and transfer dust seal (B) are necessary, use the following REPAIR PROCEDURE to install the new oil seals.

**NOTE:** Deflector (C) may not be reused.

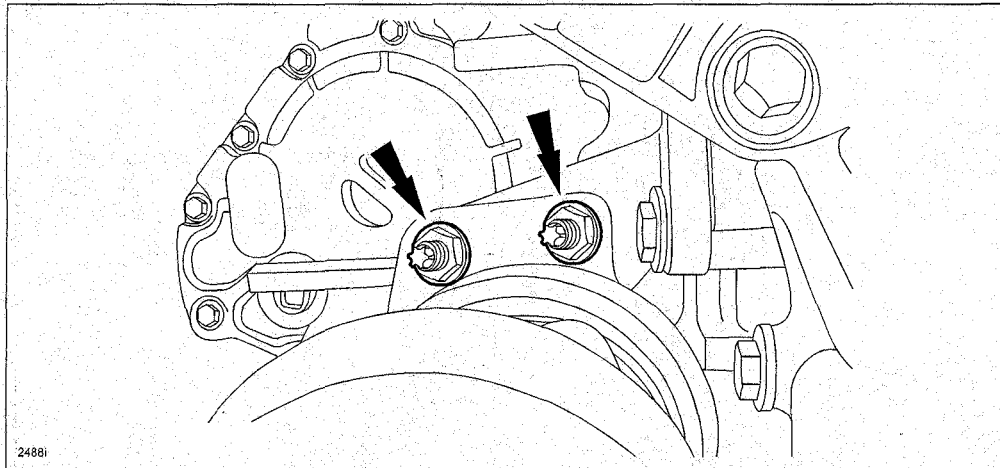
**CAUTION:** The sharp edges of the drive shaft can slice or puncture the oil seals. Be careful when removing the drive shaft from the transaxle.

15. Remove the 2 RH drive shaft bolts and the drive shaft assembly.

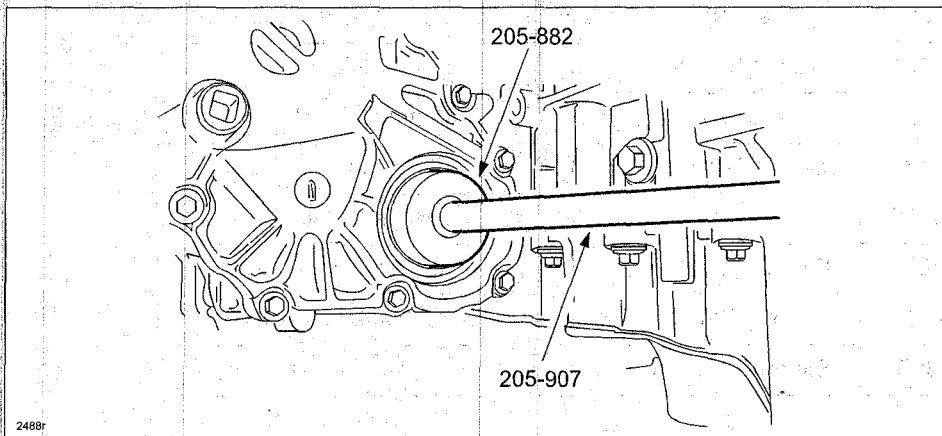
**CAUTION:** Use gloves when handling the deflector as it may be hot after Step 22.

23. Use SST part number 205-907 and part number 205-882 to install the new deflector to the case until it seats.
