<b>Subject:</b> <b>REAR DIFFERENTIAL VENT CAP FLUID LEAK IN COLD AMBIENT TEMPERATURES</b>	<b>Bulletin No:</b> 03-003/13
	<b>Last Issued:</b> 10/31/2013

2011 Tribute equipped with AWD

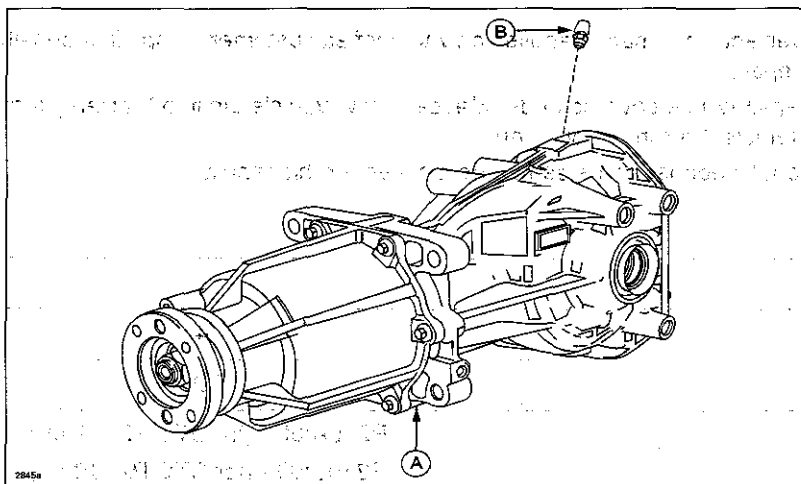
Some vehicles may exhibit an occasional fluid leak coming from the rear differential vent cap in temperatures below 32 degrees Fahrenheit (0 degrees Celsius) under certain conditions.

1. Inspect the rear drive unit (A) for oil leaking from the vent cap (B) located on the rear cover.

**NOTE:** A light residue found around the cap is normal.

3. Remove and discard the vent from the rear drive unit cover.
4. Install new vent.
5. Clean off any remaining residue.
6. Verify repair.
