TO: Mercedes-Benz Dealer Principals, General Managers, Sales Managers, Service Managers, Parts Managers	FROM: Thomas Brunner, Department Manager, Vehicle Compliance and Analysis, Engineering Services
RE: Service Campaign 2013020001 – Model X164, Model Year 2012 Apply Seam Seal to the Right A-Pillar	DATE: March 1, 2013

Campaign No. 2013020001, March 2013

SUBJECT: **Model X164, Model Year 2012**
Apply Seam Seal to the Right A-Pillar

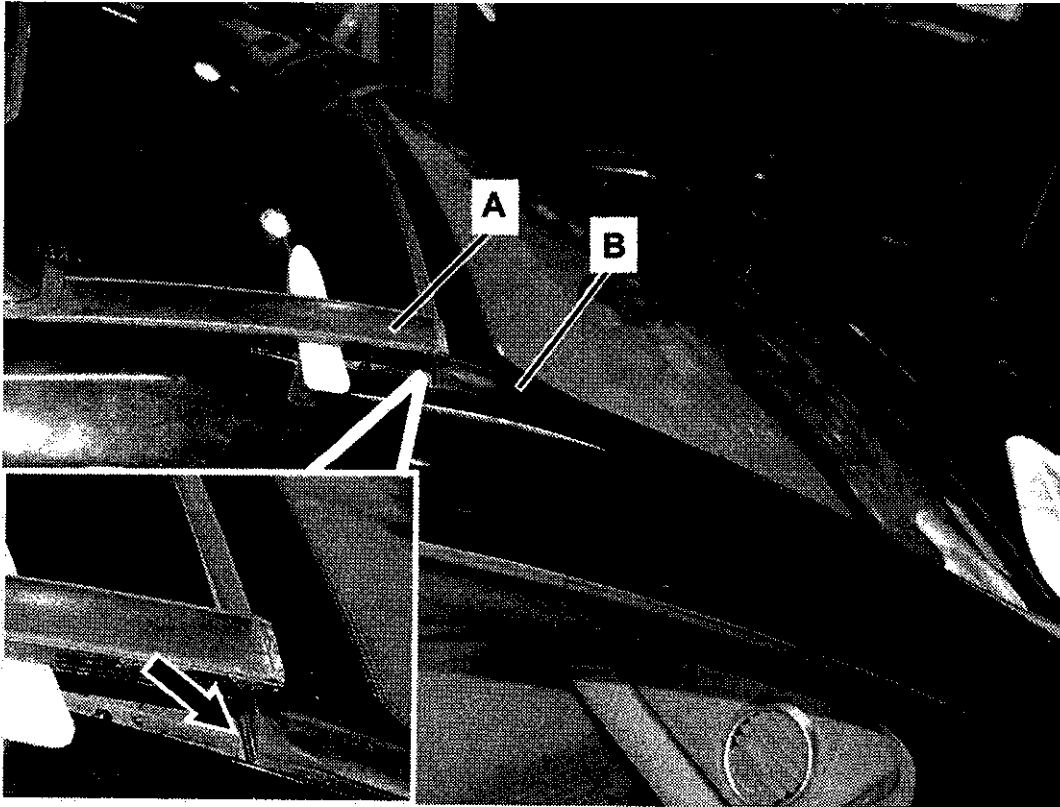
Figure 3

This Service Campaign has been initiated because Daimler AG (DAG), the manufacturer of Mercedes-Benz vehicles, has determined that the seam seal at the right A-Pillar may be missing due to a production issue. An authorized Mercedes-Benz dealer will apply seam seal on the right A-Pillar at the next workshop service.

4. Support roof molding (A, Figure 3) with plastic wedge.

5. Clean area (arrow, Figure 3) under water rail (B) to be reworked.

6. Apply seam seal to body seam (arrow, Figure 3) located under water rail (B) with an acid brush.

Do not attempt to lift or remove water rail (B) this will cause damage to the rail.

7. Allow seam seal to dry for approx. 20 minutes then apply touch-up paint.
8. Assemble in the reverse order.
