| RE: Service Campaign 2013040003- Model 212 (E-Class), 218 (CLS), Model Year 2013. Re-torque Horn Bracket Bolt | DATE: May 3, 2013 |

Campaign No. 2013040003, May 2013

SUBJECT: **Models 212, 218, Model Year 2013**
Re-torque Horn Bracket Nut

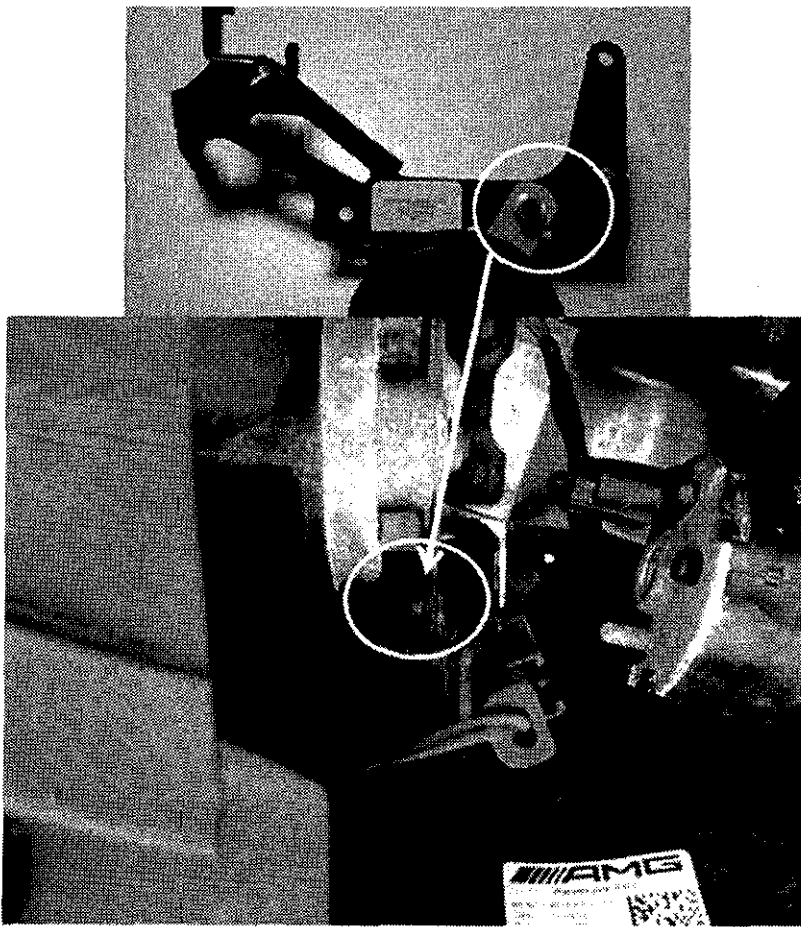
**Figure 1**

This Service Campaign has been initiated because Daimler AG (DAG), the manufacturer of Mercedes-Benz vehicles, has determined that the tightening torque of the right horn bracket may not be to specification due to a supplier process issue. The sound produced by the loose horn may not have the desired tone. An Authorized Mercedes-Benz dealer will re-torque the horn bracket nut at the next workshop visit.

1. Remove front lower engine compartment paneling; refer to WIS: AR61.20-P-1105EW.
2. Re-torque right horn mounting nut (arrow, Figure 1):

- Loosen horn mounting nut (arrow) using a wrench or ratcheting box wrench (locally procured).
- Re-torque nut (arrow) to 9 Nm using a 10 mm crow-foot wrench attached to a torque wrench. Repeat this process a **total** of 3 times.
- Remove nut (arrow) and apply thread-locking compound (shop supply) to threads then re-torque a fourth time to 9 Nm.

Be sure to position right horn back to installed position on bracket before re-torquing nut (arrow) for final time.

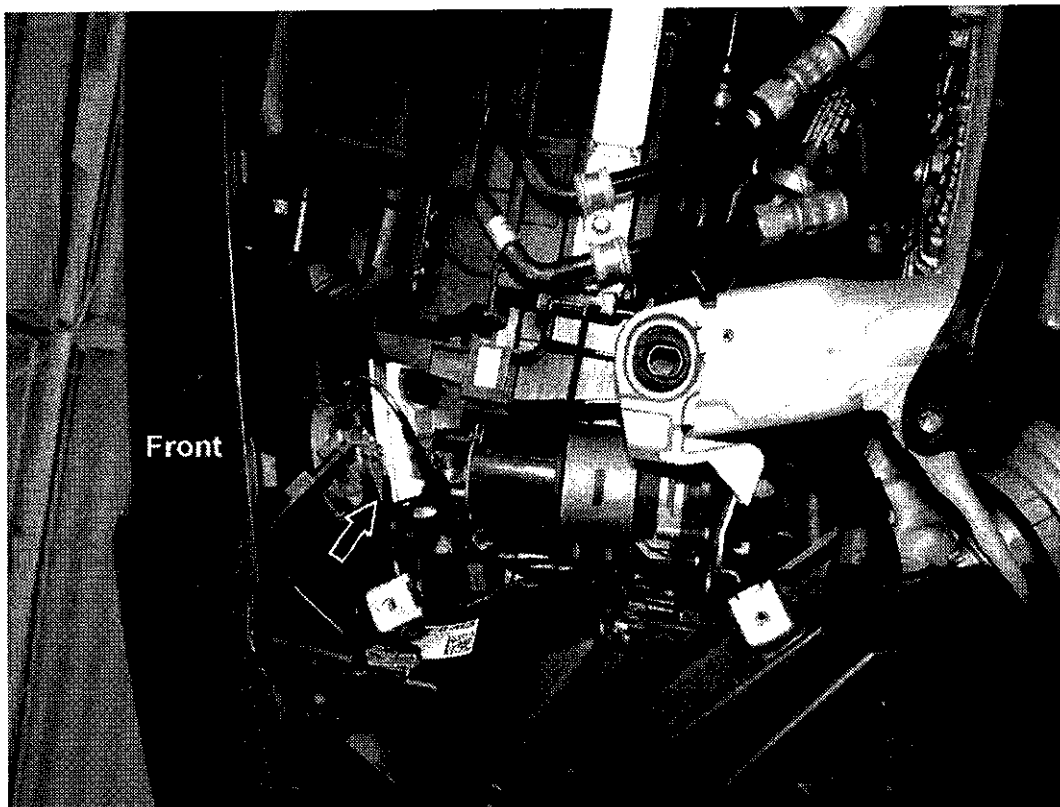
Figure 2 (Arrow points to horn mounting nut)
