TO: Mercedes-Benz Dealer Principals, General Managers, Sales Managers, Service Managers, Parts Managers	FROM: Thomas Brunner, Department Manager, Vehicle Compliance and Analysis, Engineering Services
RE: Service Campaign 2013100005 – Check Seam Seal at Under-floor. Models 204 (C), X204 (GLK), 207 (E-Coupe) Model Year 2013.	DATE: November 22, 2013

Campaign No. 2013100005, November 2013

SUBJECT: **Models 204 (C), X204 (GLK), 207 (E-Coupe) Model Year 2013**
Check Seam Seal at Under-floor

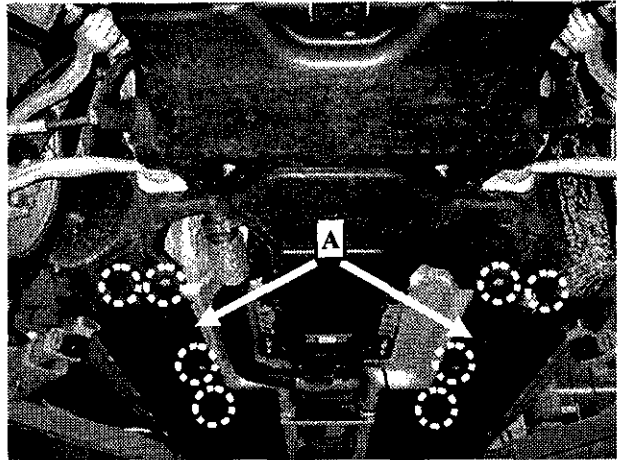
Figure 1

1. Remove screws or nuts (circled, Figure 1) to loosen left and right under-floor paneling (A).

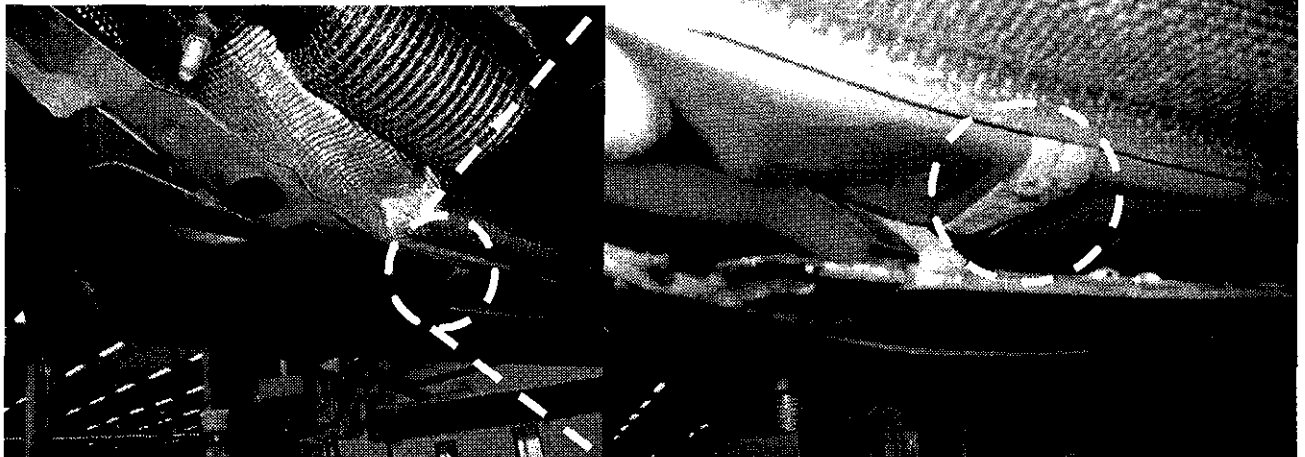
Figure 2

This Service Campaign has been initiated because Daimler AG (DAG), manufacturer of Mercedes-Benz vehicles, has determined that the seam seal on the under-floor may have been damaged during the manufacturing process. An authorized Mercedes-Benz dealer will check, and if necessary, repair the under-floor seam seal at the next workshop visit.

Pull away under-floor paneling using plastic wedge and check seal seam at left and right main floor longitudinal member for damage (circled, Figure 2):
 - If seal seam (circled) is **not** damaged (OK): Procedure is complete, assemble in reverse order.
 - If seal seam (circled) **IS** damaged (NOT OK): Proceed to step 3.

- Thoroughly clean area to be repaired and then de-grease with silicone remover.
- Apply missing seam sealant then allow to dry for approx. 20 minutes.
- Apply under-floor protection wax.
