GROUP	NUMBER			
CO HYUNDAI NEW THINKING. NEW POSSIBILITIES	Campaign	13-01-038			
Technical Service Bulletin	DATE	MODEL(S)			
rechnical Service Bulletin	September 2013	2013 MY Santa Fe (NC)			
SUBJECT: OVERHEAD CONSOLE LA	ECT: OVERHEAD CONSOLE LAMP INSPECTION AND REPLACEMENT				
(SERVICE CAMPAIGN TQ4)

This bulletin describes the procedure to inspect and/or replace the Santa Fe overhead console lamp.

### Applicable Vehicles: 2013 Model Year Santa Fe (NC)

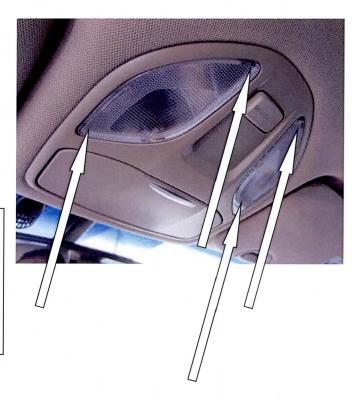
Check if any of the overhead console lamp hinges are broken.
Press on each of the 4 arrows of the overhead console lamp 5 times each.

> If there are any broken hinges; the plastic lens cover will not be flush with the rest of the console. Proceed to "OVERHEAD CONSOLE REPLACEMENT PROCEDURE".

When pressing the lens cover to activate the lights, if the lens do not move freely proceed to "OVERHEAD CONSOLE REPLACEMENT PROCEDURE".

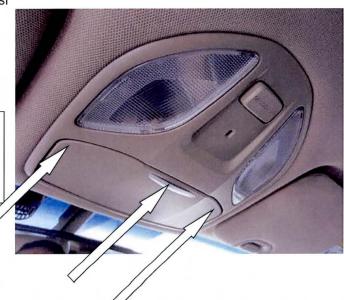
Press the 3 locations to verify free opening and closi ng of the sunglass holder.
If the opening and closing motion is free of obstruction. No further action is required.

If the sunglass holder is not flush with the adjustment trim, or does not open and close freely, proceed to "OVERHEAD CONSOLE REPLACEMENT PROCEDURE ".
