<b>Subject:</b>  HARD TO SHIFT INTO GEARS	<b>Bulletin No:</b> 05-007/13
	<b>Last Issued:</b> 12/12/2013

2014 Mazda3 (M/T) with VINs lower than JM1BM\*\*\*\*\*144465 (produced before November 11, 2013)

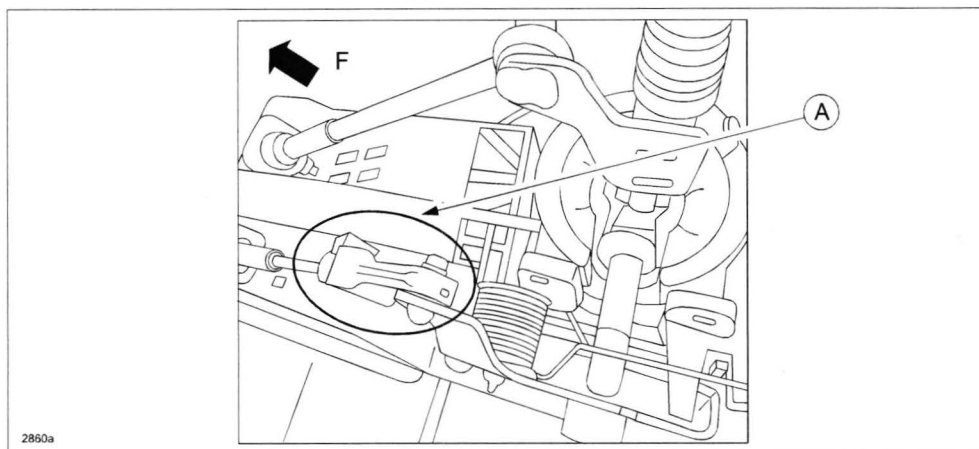
1. Verify customer concern.
2. Remove the shift panel. Refer to MS3 online instructions or Workshop manual (section 09-17 SHIFT PANEL REMOVAL/INSTALLATION).
3. Install the shift lever knob and shift into 4th gear.
4. Find the adjuster for the control cable (A).  
F: Front of vehicle

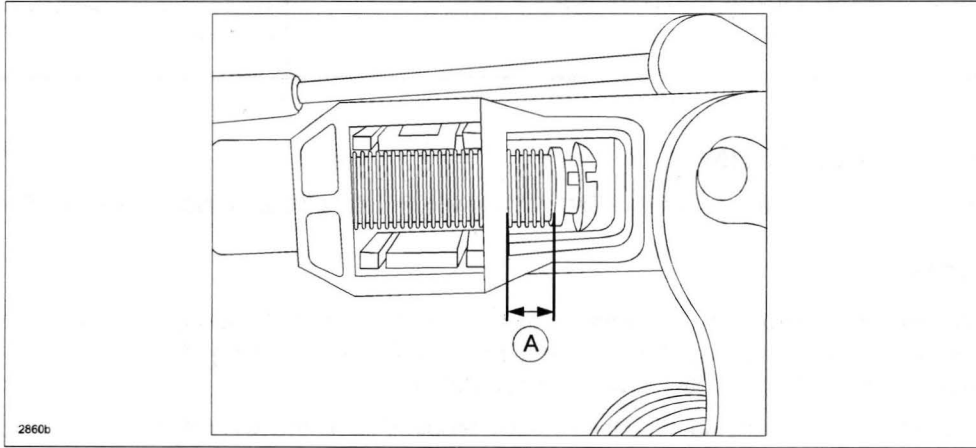
5. Check the current adjustment condition of the control cable by counting the number of projecting thread turns (A).

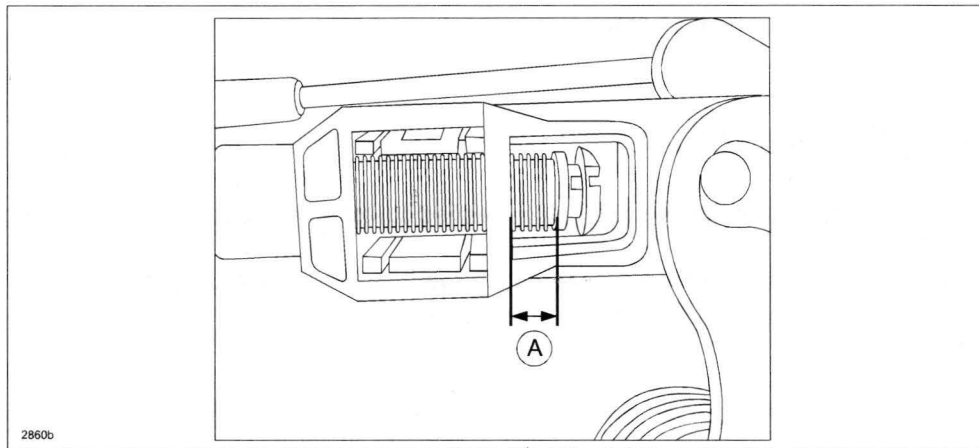
9. Check that the cable adjustment condition (number of thread turns (A)) has changed from the previous check.
