Service Bulletin

Subject: RATTLE NOISE FROM STEERING SYSTEM	Bulletin No: 06-001/13
	Last Issued: 08/22/2013

APPLICABLE MODEL(S)/VINS

2011-2012 Mazda2 vehicles with VINs lower than JM1 DE 1**** 140732 (produced before December 10, 2011)

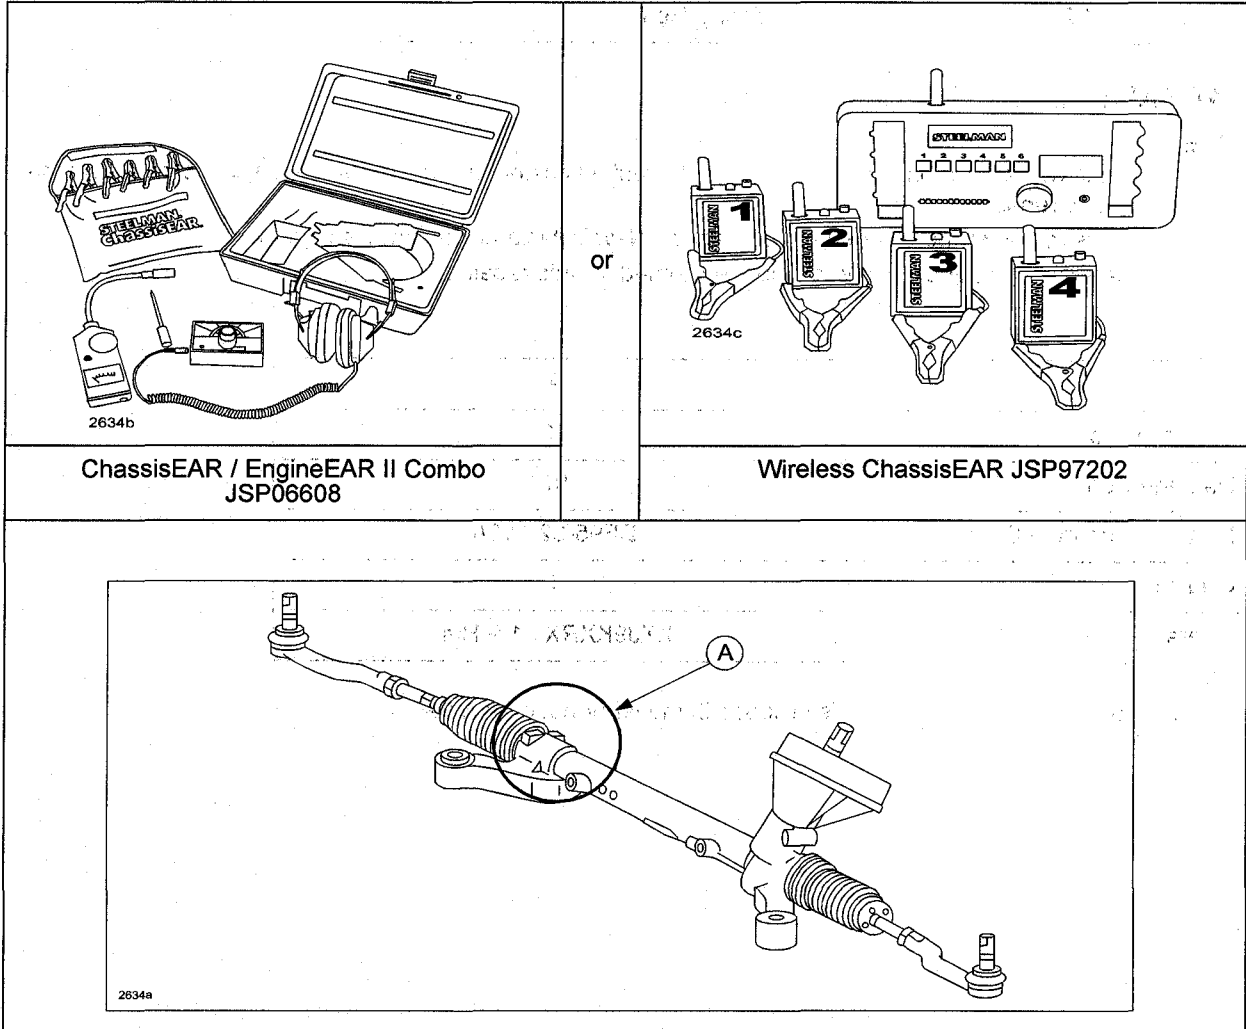
When driving straight on a rough road at approximately 6-19 mph (10-30 km/h), some vehicles may exhibit a rattle noise from the front passenger side floor.

2. Use Special Service Tool (SST) ChassisEAR / EngineEAR II Combo JSP06608 or Wireless ChassisEAR JSP97202 to confirm rattle noise is coming from the rack end bushing (A) (shown below):

3. If step 1-2 apply, replace the steering gear assembly according to MS3 online or Workshop Manual (section 06-13 STEERING GEAR AND LINKAGE REMOVAL/INSTALLATION).
4. Verify repair.
