Subject: CLACKING NOISE WHEN STARTING TO MOVE VEHICLE WHILE STEERING WHEEL IS TURNED TO FULL LEFT POSITION	Bulletin No: 06-002/13
	Last Issued: 10/09/2013

2013-2014 CX-5 vehicles with VINs lower than JM3KE*****369145 (produced July 3, 2013)

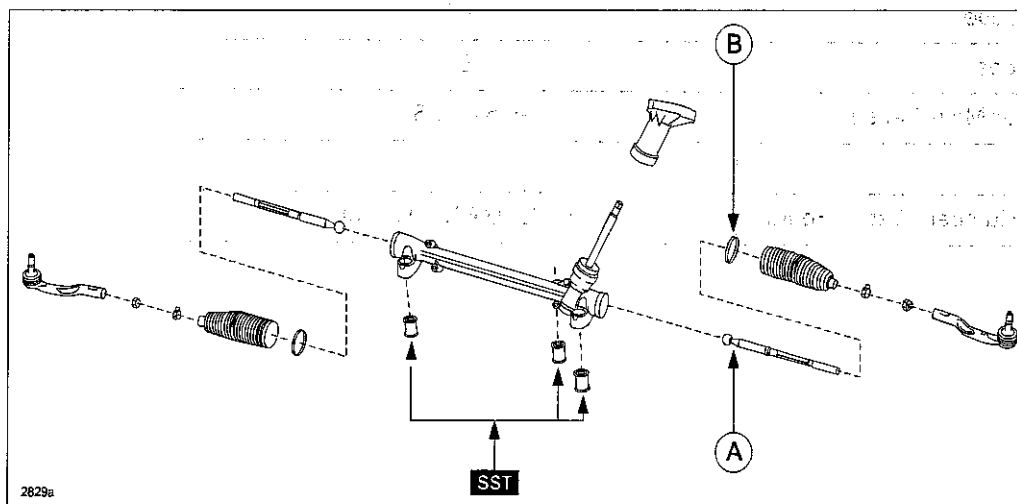
Some vehicles may exhibit a clacking noise from under the front of the vehicle. This noise only occurs when starting to move the vehicle while the steering wheel is turned to the full left position.

The noise is caused when the edge of the left side inner ball joint (A) gets stuck with the steering gear housing. The shape of the inner ball joint edge has been changed to eliminate this noise.

1. Verify the customer concern by turning the steering wheel full left, then start moving the vehicle.
2. Remove the steering gear and linkage according to the on-line instructions on MS3 or the Workshop Manual (section 06-13 STEERING GEAR AND LINKAGE REMOVAL) and replace the left inner ball joint (section 06-13 STEERING GEAR AND LINKAGE DISASSEMBLY).

NOTE: Be sure to replace wire clamp (B), the joint bolt and both snap pins.
