# Service Bulletin

| <b>Subject:</b><br>CHIRP NOISE FROM RIGHT REAR AT 60 MPH OR MORE | <b>Bulletin No:</b> 09-001/13 |
| | <b>Last Issued:</b> 11/11/2013 |

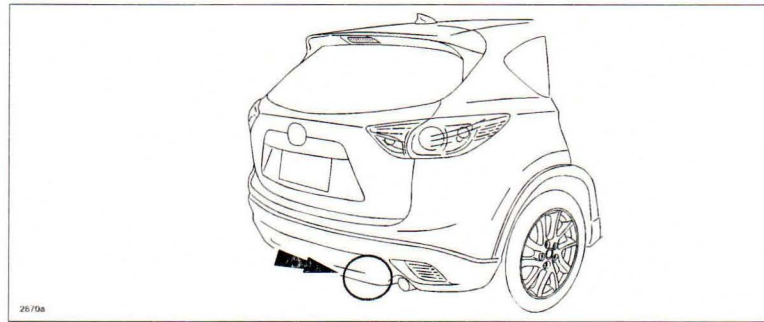
While driving at approx. 60 mph or more, some vehicles may exhibit a chirp noise from rear right end of the vehicle.

The chirp noise may be caused by the right side rear bumper stay hook (A) contacting the bumper reinforcement (B) at high speed. The shape of the reinforcement hole has been changed on both sides to eliminate the noise. Also, pads have been added to the bumper stay to prevent contact noise.
