| Subject: 2013 CX-5 - CHIRP NOISE FROM RIGHT REAR AT 60 MPH OR MORE | Bulletin No: 09-001/13 |
| | Last Issued: 02/15/2013 |

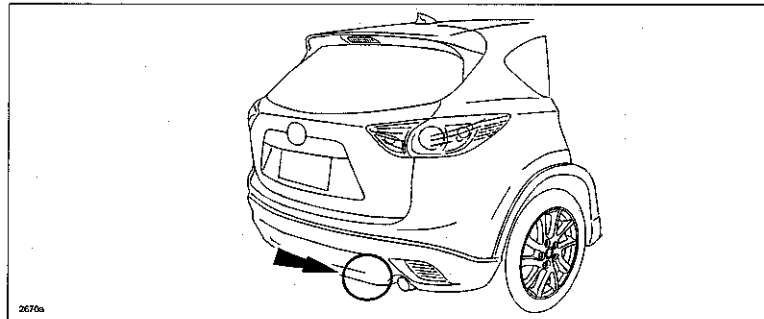
While driving at approx. 60 mph or more, some vehicles may exhibit a chirp noise from rear right end of the vehicle.

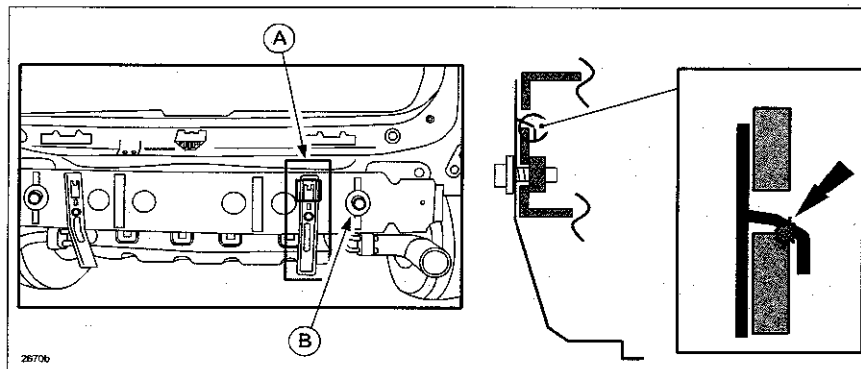
The chirp noise may be caused by the right side rear bumper stay hook (A) contacting the bumper reinforcement (B) at high speed. The shape of the reinforcement hole has been changed on both sides to eliminate the noise.

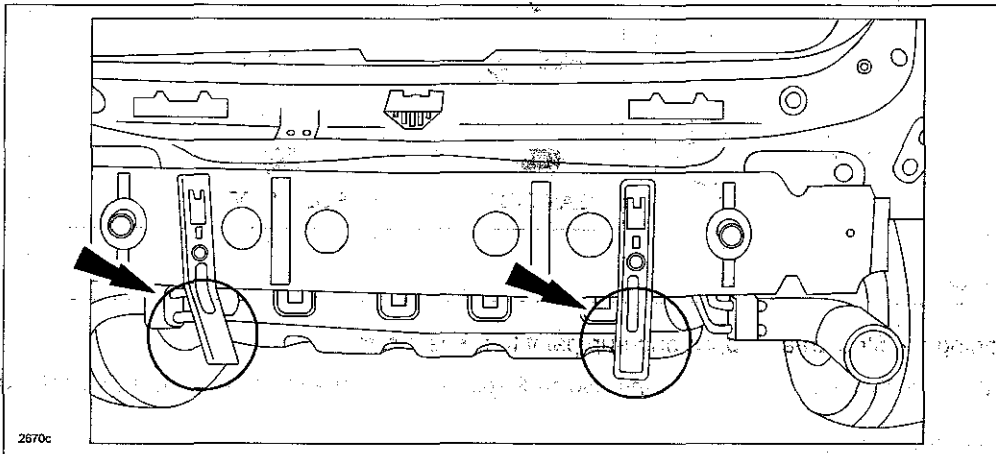
1. Verify the customer concern by lightly tapping the left and right sides of the rear bumper by hand.
 - If the noise is heard on either side, follow the repair procedure below to eliminate the concern.
 - If the noise is not heard on either side, this service bulletin is not applicable.
2. Remove the rear bumper from the vehicle according to the instructions on MS3 online or the Workshop Manual (section 09-10 REAR BUMPER REMOVAL/INSTALLATION).
3. Confirm the chirp noise again by hitting the lower side of left and right bumper stays by hand.

NOTE: Even if there is no chirp noise on the left side, perform the repair on both sides.
