Service Bulletin Mazda North American Operations Irvine, CA 92618-2922

DRIVER-SIDE POWER DOOR MIRROR VIBRATION

Bulletin No: 09-002/13

2013-2014 CX-5

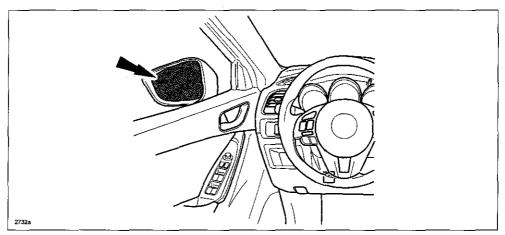
Some vehicles may exhibit a vibration from the driver-side power door mirror glass when the vehicle is driven at high speeds.

This concern may be due to a lack of rigidity of the mirror base so the mirror vibrates when it receives vehicle vibration or wind pressure.

Customers having this concern should have their vehicle repaired using the following repair procedure.
