GROUP ACC	MODEL 2014MY Forte (YD)
	NUMBER 008	DATE October 2013
TECHNICAL SERVICE BULLETIN		
SUBJECT: SERVICE ACTION: GAP BETWEEN FORTE SPOILER AND TRUNK LID (SA154)

This issue number is SA154.

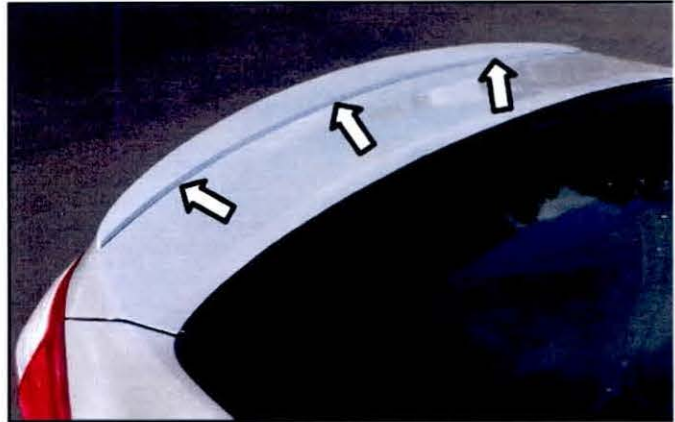
1. Inspect leading edge of the spoiler for a possible gap forming between the spoiler and the trunk lid.

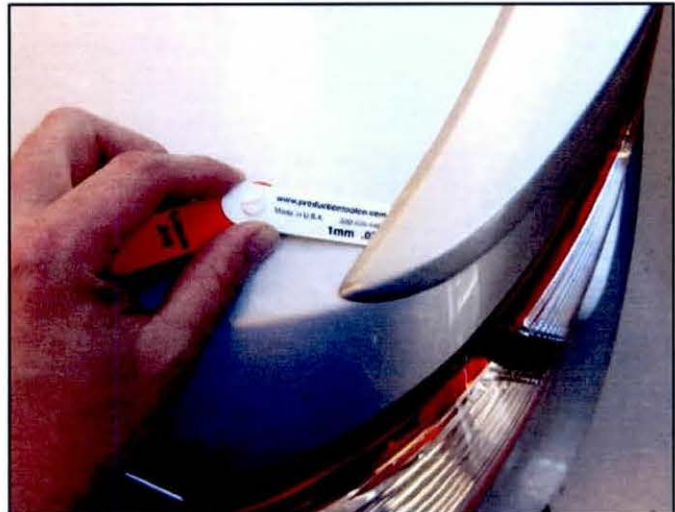
2. If any gaps are present, use a 1mm plastic feeler gauge to measure the separation.
 - If the gap is equal to or greater than 1.0 mm, remove and replace with a new spoiler by carefully following the instructions included with the new accessory part.
 - If the gap is less than 1.0 mm, proceed to Step 3.

Do not use metal feeler gauges or paint damage may occur.

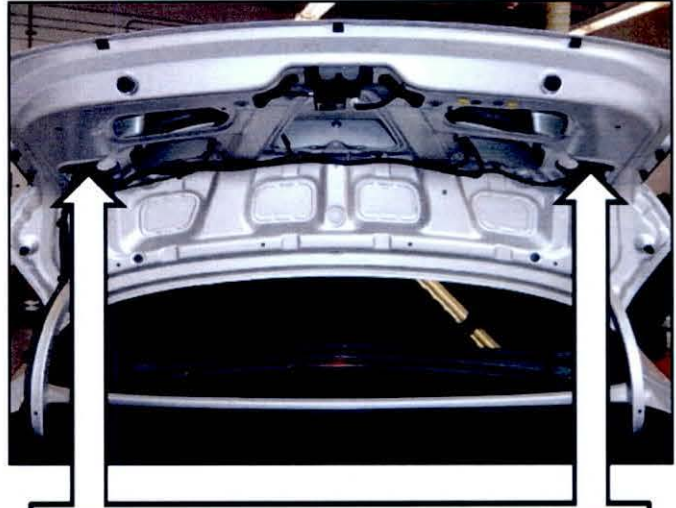
4. Inspect the retaining clips to make sure the hooks are properly engaged on the underside of the trunk.
