GROUP BOD	MODEL Sorento (XMa) 2011-2013MY
	NUMBER 093 (REV 3, 10/31/2014)	DATE February 2013

## TECHNICAL SERVICE BULLETIN

**SUBJECT:** SECOND ROW SEAT INOPERATIVE OR DIFFICULT TO RELEASE

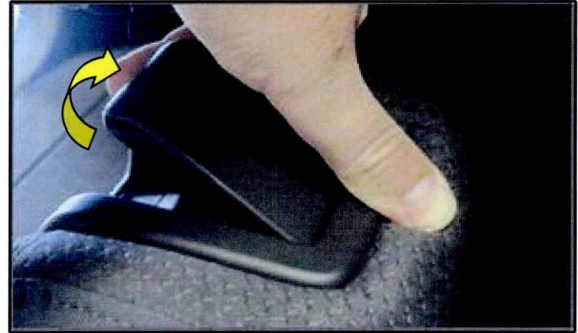
You may need to apply pressure to the seatback in order to free a jammed recliner mechanism.

Verify excessive effort required to operate handle.
