MODEL
2013MY
Sorento (XMa)

NUMBER
PS239

SUBJECT: RATTLE FROM THE RIGHT AND/OR LEFT SIDE OF DASHBOARD

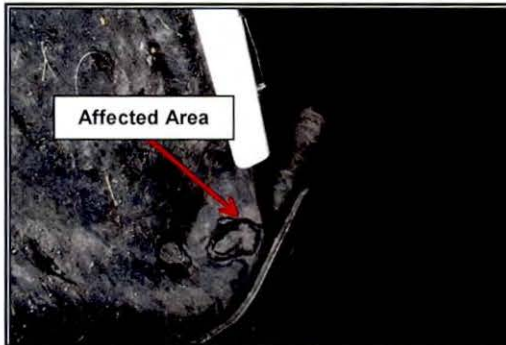
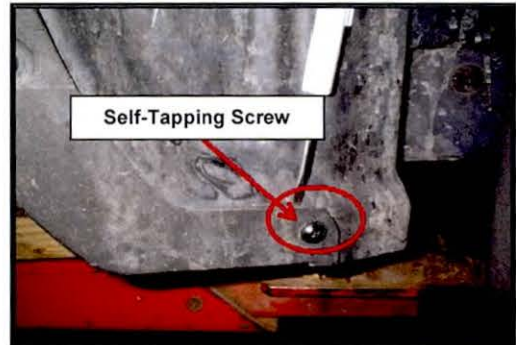
Some customers may complain of a rattle type noise coming from the right and/or left side of the dash while driving at highway speeds. This concern may be caused by the fender trim rubbing against the fender liner. To resolve this concern, use a self-tapping screw to secure the fender trim and the fender liner, as shown. Test drive the vehicle and confirm the noise is no longer present.

Part Number	Description	Qty.
12431-03127B	T/SCREWG	1
