MODEL  
Optima Hybrid  
(TF HEV)

NUMBER  
PS241

DATE  
February 2013

**SUBJECT:** HARSH ENGAGEMENT FROM TRANSMISSION AT  
LOW SPEEDS

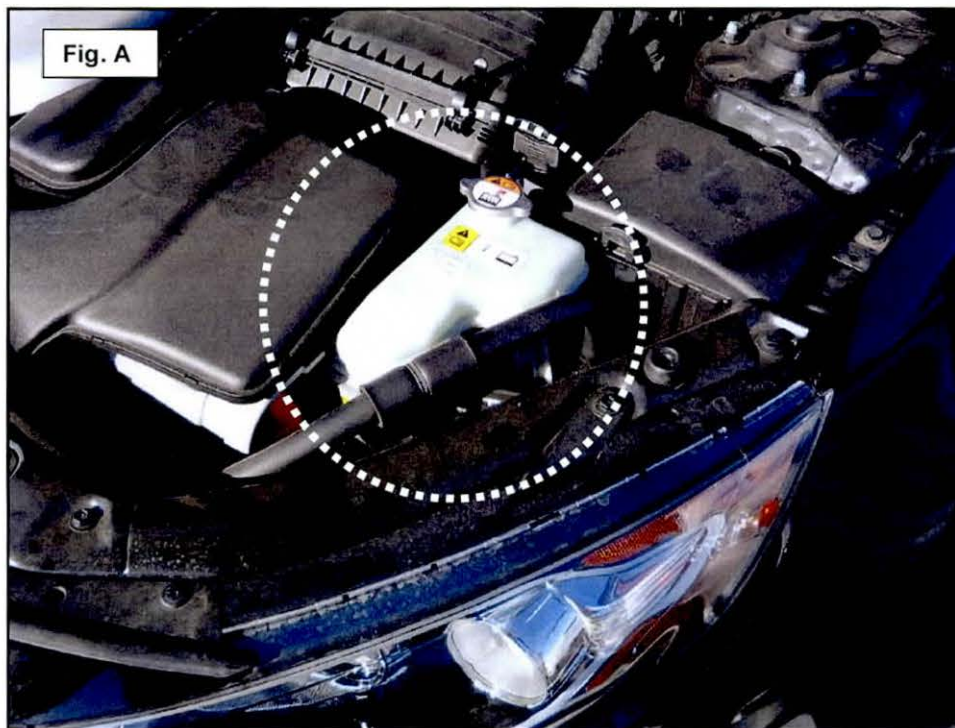
If you encounter a customer complaint relating to harsh engagement from the transmission at low speeds, check the HPCU/HSG coolant reservoir is at the proper level and that no leaks are present (Fig. A). Also, check the Electric Water Pump (EWP) operation using the GDS "Actuation Test". Do not rely on the "Success" message displayed on GDS as proof of proper pump operation. Listen for the pump noise coming from the right front fender area in order to confirm operation. If the EWP makes no noise while in operation, diagnose further and repair accordingly.
