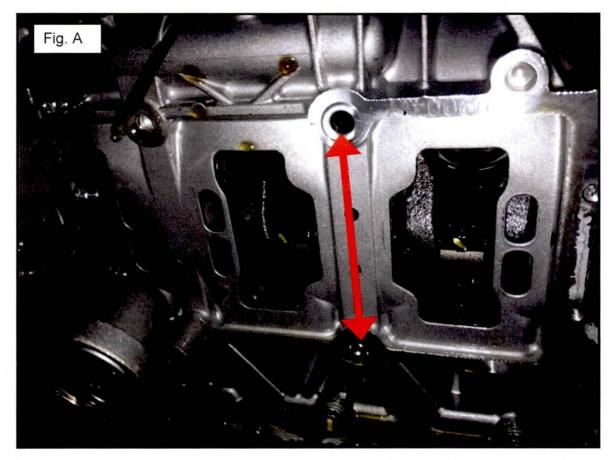
When replacing the short block on a Forte 2.0L engine, make sure to remove two ladder frame bolts from the block being replaced and install them in the locations shown on the replacement block (Fig. A). Failure to transfer the ladder frame bolts will result in the engine having no oil pressure when started.
