MODEL
2012-2013MY
Soul (AM)

NUMBER
PS258

SUBJECT: INSTRUMENT CLUSTER ILLUMINATION ADJUSTMENT

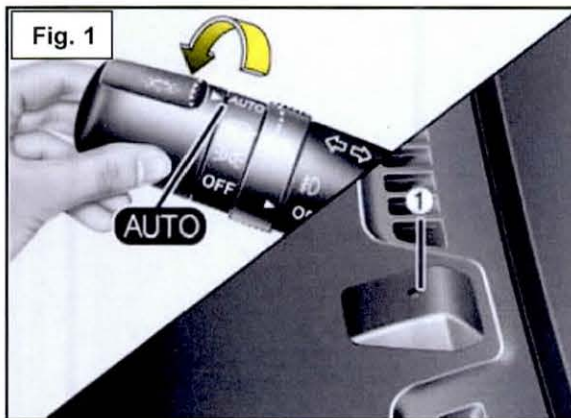
When diagnosing a customer concern relating to the inability to dim the instrument cluster in day time driving conditions, inspect the center of the dash for the presence of the Auto Light Sensor (Fig. 1). If the sensor is present, the vehicle is equipped with the Auto Headlamp Feature and the cluster will only be dimmable during night time driving conditions.

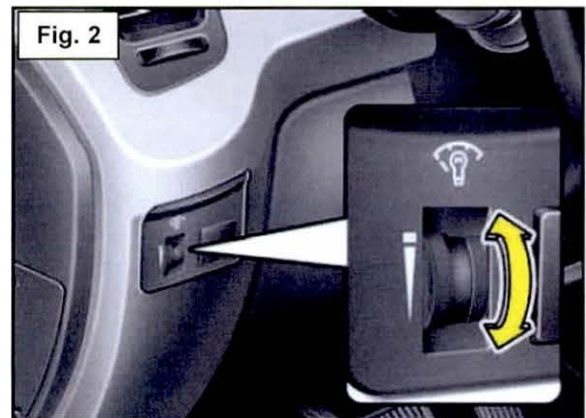
In order to verify this feature is operating correctly, turn the key to the 'ON' position, turn the head lamp switch to 'ON' or 'Auto', cover the Auto Light Sensor with a dark piece of cloth to block out all light. Now that you are simulating night time driving conditions, dim the cluster brightness using the dimmer switch (Fig. 2).

On Base models without the Auto Lamp feature, the cluster brightness can be adjusted, at anytime, using the dimmer switch (Fig. 2).
