MODEL
2011-2013MY
Sorento (XM)

NUMBER
PS269

SUBJECT: GRINDING OR CREAKING NOISE WHEN TURNING

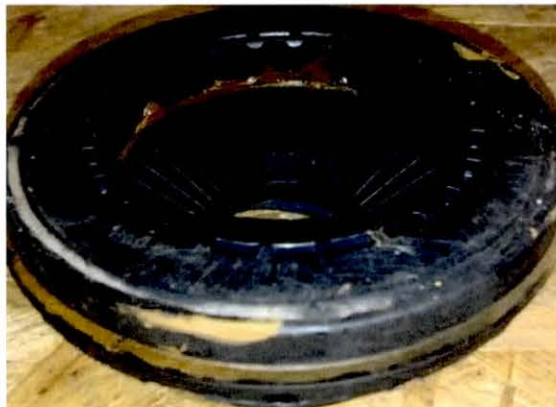
This article provides information regarding a potential grinding or creaking noise heard from the front of the vehicle when turning the wheel quickly at slow speeds, on some 2011 - 2013MY Sorento (XMa), produced prior to August 28, 2012. This concern may be caused by corrosion of the Front Strut Bearing due to water or debris entry and is more commonly found in regions with higher snowfall and road salt usage.

Verify the customer complaint of a grinding or creaking noise during turning and remove the front strut bearings for inspection. If there is a rough feeling when turning the bearing by hand, replace it with a new part and recheck to verify that the noise is no longer heard.
