GROUP Electrical	MODEL 2011-12MY Sorento (XM)
	NUMBER 051	DATE April 2013
<b>TECHNICAL SERVICE BULLETIN</b>		
SUBJECT: SERVICE ACTION: DRIVER'S SIDE POWER WINDOW MOTOR REFLASH PROCEDURE (SA 143)

This bulletin provides information relating to some Sorento (XM) vehicles produced from January 28, 2010 to May 16, 2011, which may exhibit an inoperable driver's side window. To correct this concern, reflash the driver's side power window motor to upgrade from software version 3.8 or 3.9 to software version 3.10, by following the service procedure outlined in this bulletin. Before conducting the procedure, verify the vehicle is included in the list of affected VINs.

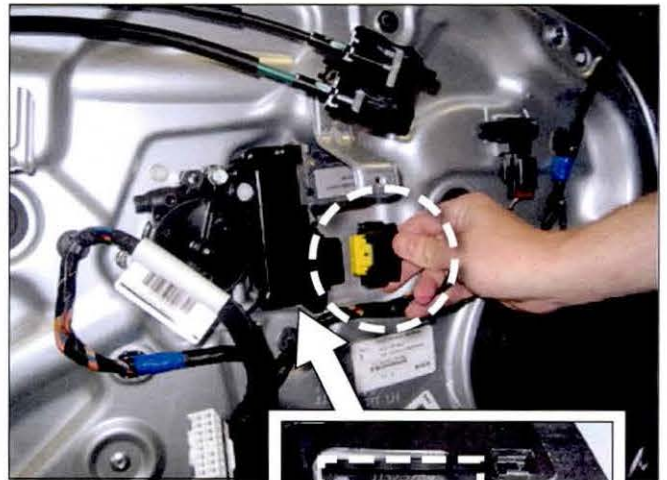
16. Confirm the software revision level by examining the area directly below the connector on the window motor. The embossed revision level should be 3.8 or 3.9. Window motors with a revision number of 3.10 (or higher) require no further action; proceed to Step 25.

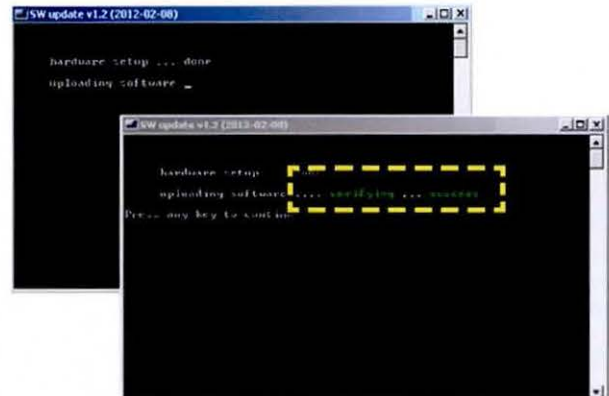
22. If the reflash procedure was successful, the screen will display the "success" message. Proceed to Step 24.

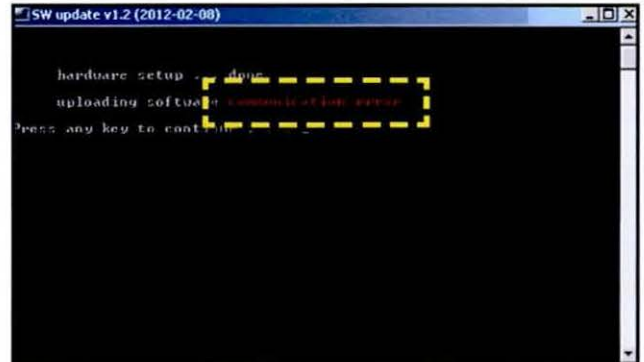
23. If the reflash procedure was unsuccessful, the screen will display the "communication error" message.

Check the following to resolve a "communication error" message:

- Reflash tool power supply is properly connected.
- RS-232 cable connector is properly connected.
- Window motor cable connector is properly connected.

After all checks are complete, perform the reflash procedure again.
