MODEL
Sorento (XMa)
2011-2013MY

NUMBER
093 (Rev 1, 08/22/2013)

TECHNICAL SERVICE BULLETIN

SUBJECT: SECOND ROW SEAT INOPERATIVE OR DIFFICULT TO RELEASE

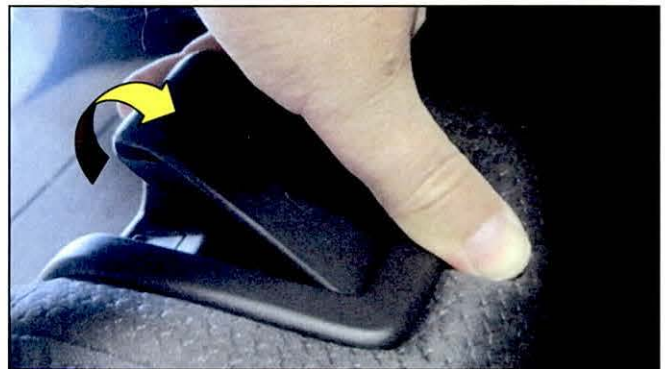
This service procedure applies only to vehicles with the RH (40%) 2nd row seat reclining mechanism not functioning properly due to a seat reclining handle which requires no effort to operate. This is likely caused by a disconnected cable in the seatback frame.

1. Operate the reclining handle to verify proper release of the seatback. If the handle requires little or no effort to operate and the seatback will not release, perform this service procedure to correct the concern.

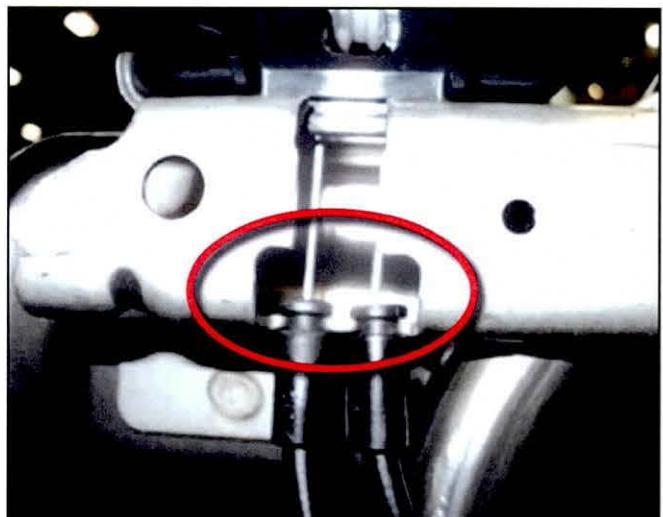
8. Make sure the cable guides are properly seated in the retaining brackets on the seatback frame. Also, inspect the cables for damage. If a cable is damaged, replace it.

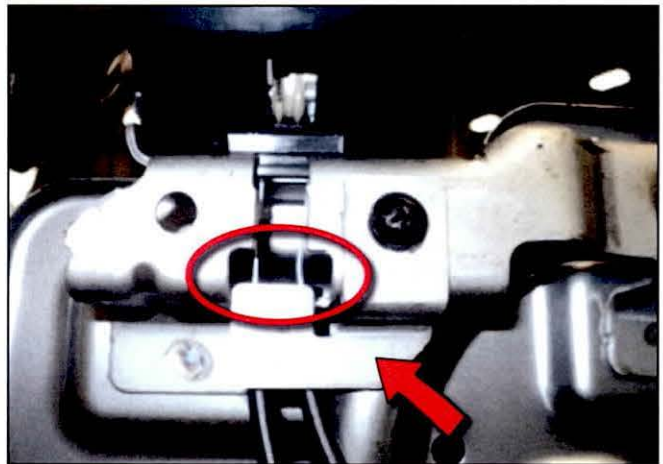
9. On vehicles produced on or after September 15, 2011, remove the bracket to ensure the cable guides are properly seated in the retaining brackets on the seatback frame. Also, inspect the cables for any sign of damage. If a cable is damaged, replace it.

Re-install the bracket before proceeding to the next step.

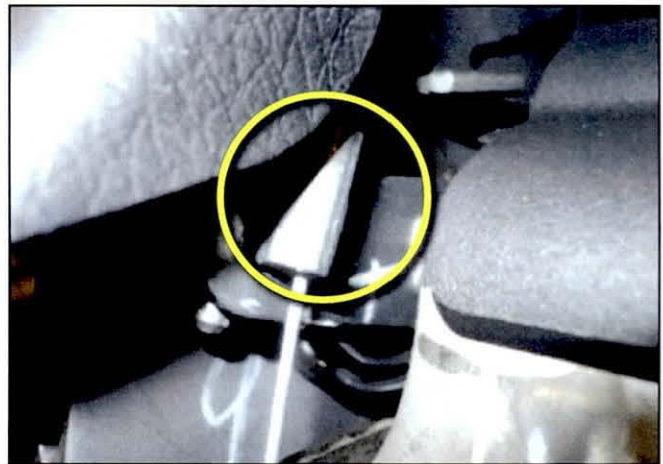
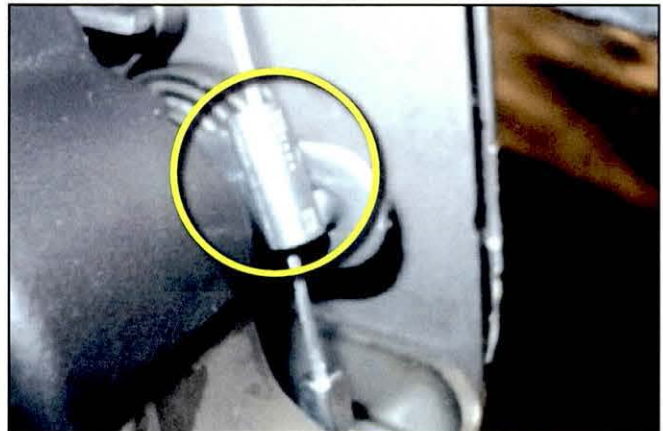
12. Inspect the seatback release cable for damage at the locations shown. If a cable is damaged, replace it.

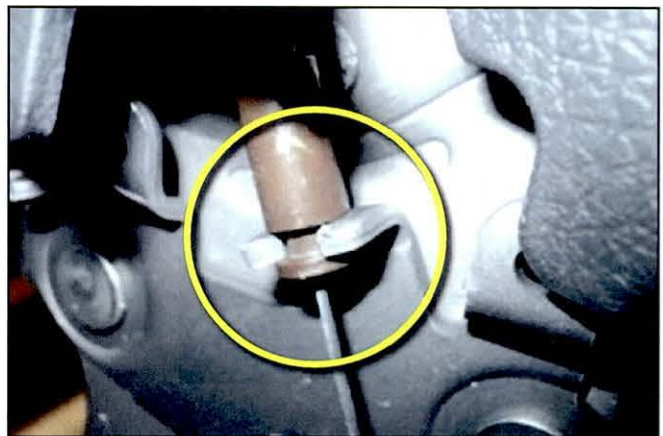
13. Make sure the seatback release cable guide is properly seated in the retaining bracket. If the cable guide is disconnected, reinstall the cable guide in the bracket to resolve the concern.

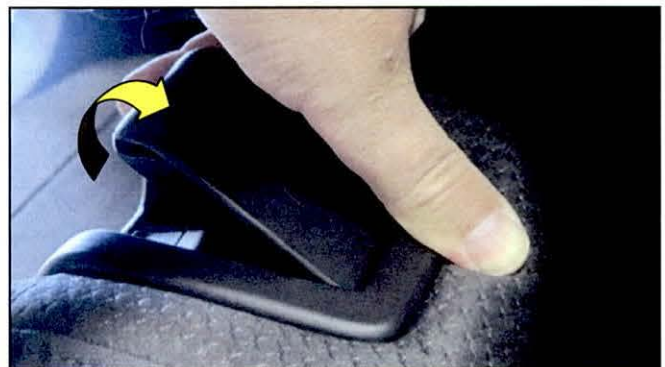
This service procedure applies only to vehicles with the LH (60%) 2nd row seat reclining mechanism not functioning properly and a seat reclining handle which requires no effort to operate. This is likely caused by a disconnected cable in the seatback frame.

1. Operate the reclining handle to verify proper release of the seatback. If the handle requires little or no effort to operate and the seatback will not fold down, perform this service procedure to correct the concern.

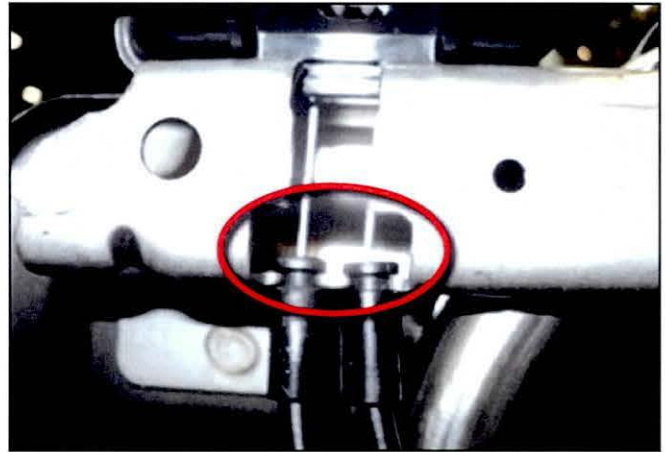
10. Make sure the cable guides are properly seated in the retaining brackets on the seatback frame. Also, inspect the cables for damage. If a cable is damaged, replace it.

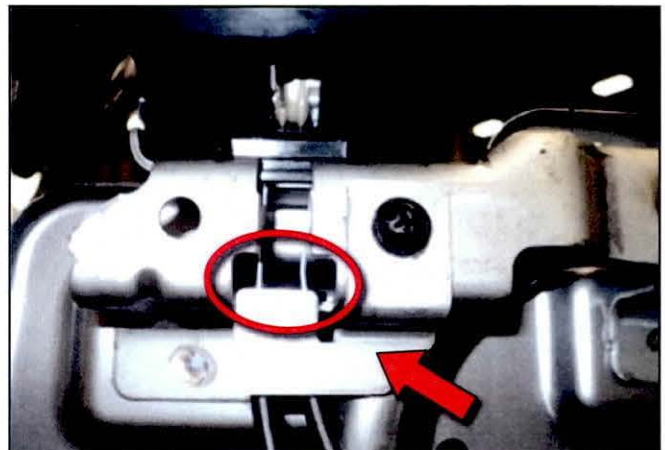
11. On vehicles produced on or after September 15, 2011, remove the bracket to ensure the cable guides are properly seated in the retaining brackets on the seatback frame. Also, inspect the cables for any sign of damage. If a cable is damaged, replace it.

Re-install the bracket before proceeding to the next step.

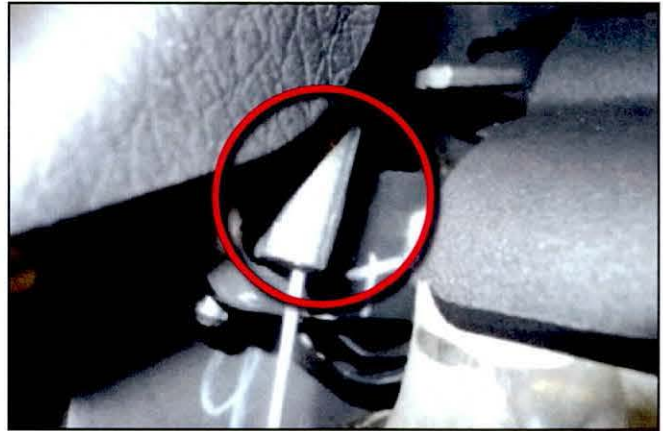
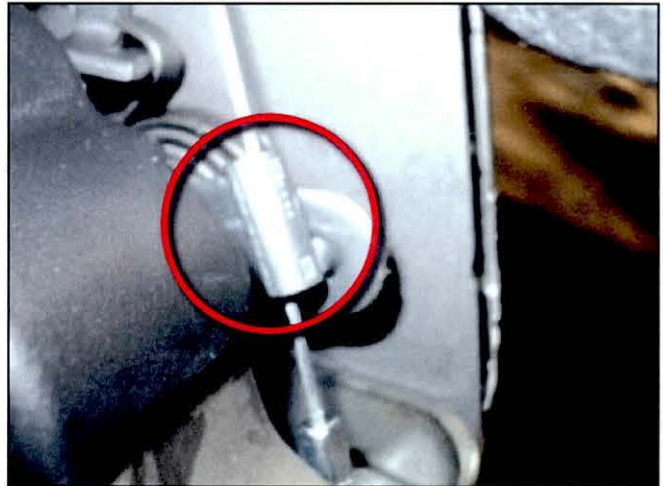
13. Inspect the seatback release cable for damage at the locations shown. If a cable is damaged, replace it.

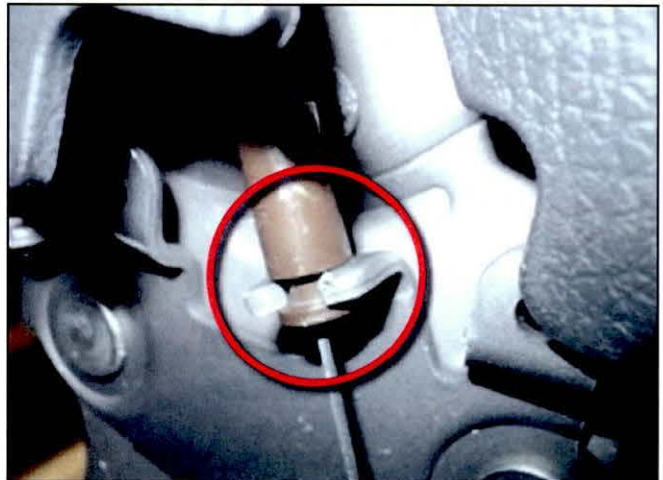
14. Make sure the seatback release cable guide is properly seated in the retaining bracket. If the cable guide is found to have become disconnected, reinstall the cable guide into the bracket to resolve the concern.

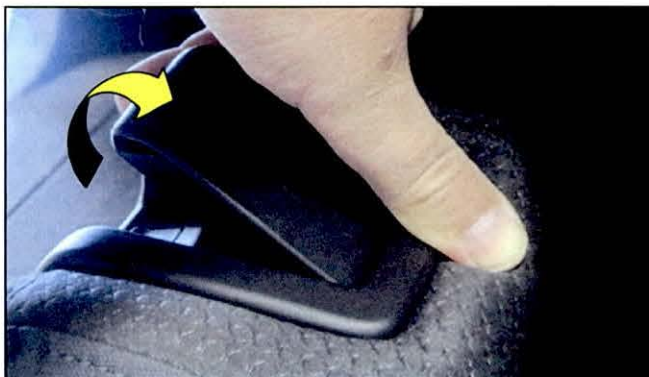
This service procedure applies only to vehicles with the RH (40%) or LH (60%) 2nd row seatback reclining handles requiring an excessive amount of effort to operate.

1. Operate the seatback reclining handle to verify excessive effort is required.
