GROUP Body	MODEL Soul (AM) 2011MY
NUMBER 096	DATE June 2013

TECHNICAL SERVICE BULLETIN

SUBJECT: SERVICE ACTION: HORN ASSEMBLY INSPECTION AND UPGRADE PROCEDURE (SA144)

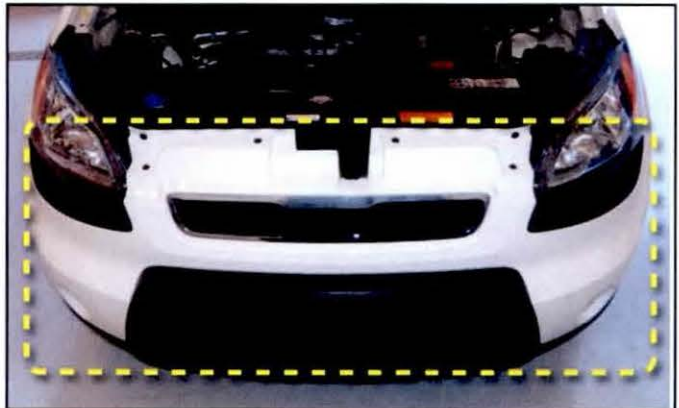
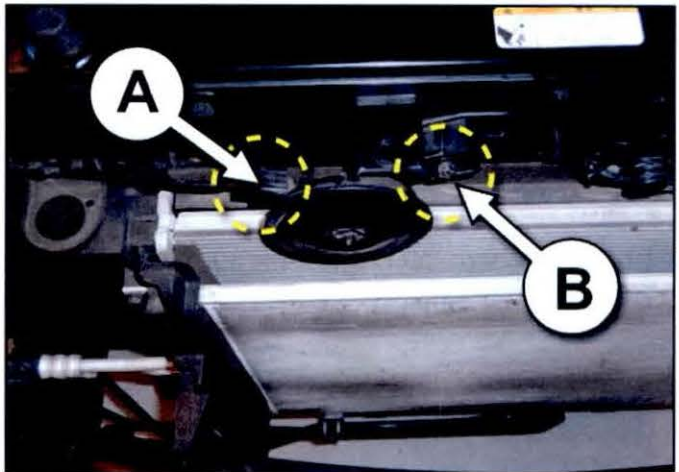
This bulletin provides the procedure to inspect and, if necessary, replace the horn assembly on some Soul (AM) vehicles, produced from September 1, 2010 to November 30, 2010. Perform the inspection procedure to determine if the horn sound is distorted or irregular and replace per the Service Procedure, if necessary. Before conducting the procedure, verify the vehicle is included in the list of affected VINs.

1. Operate the horn and check for irregular or distorted sound quality. If horn operates correctly, no further steps are required.
2. If horn exhibits poor or irregular sound, proceed to the Service Procedure.

1. Open the hood.
2. Remove the front fascia by referring to the Service Information on KGIS.
3. Locate the horn and remove the harness connector (A) and the bolt (B) securing the horn bracket to the vehicle.
