MODEL
2006-2014MY
Sedona (VQ)

NUMBER
101 (REV 1, 11/08/2013)

TECHNICAL SERVICE BULLETIN

SUBJECT: FRONT DOOR GLASS RUN CHANNEL REPLACEMENT

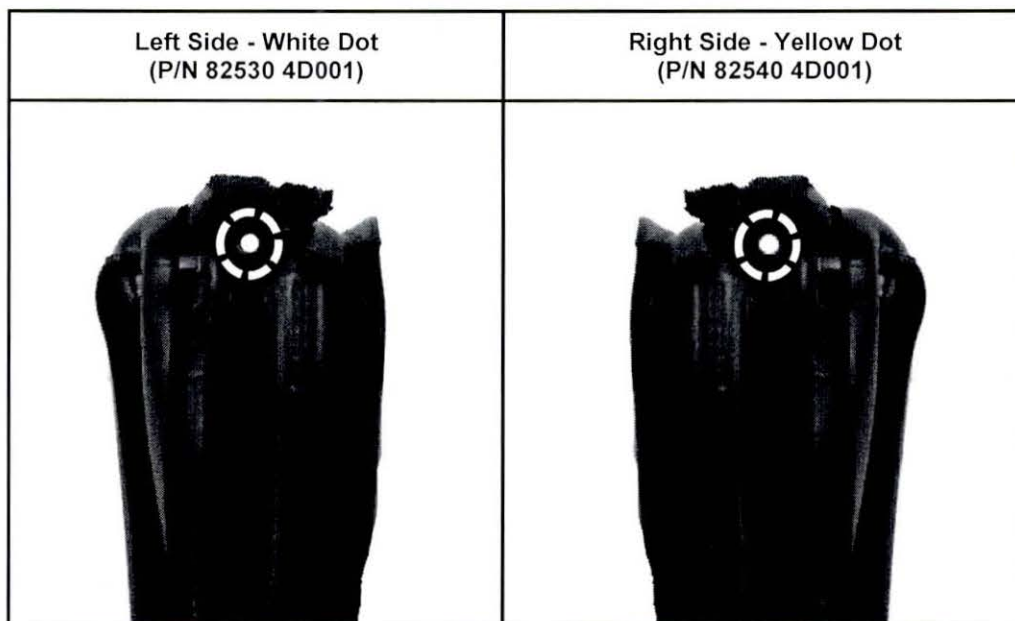
Refer to the table below to identify the right and left side glass run channels. Look for a Yellow or White dot painted on a projection on the underside of each glass run channel.
