GROUP <b>Body</b>	MODEL <b>All Models</b>
	NUMBER <b>PS278</b>	DATE <b>October 2013</b>

<b>SUBJECT:</b> EFFECTS OF CHEMICAL CLEANERS ON HEADLAMPS

# TECH TIMES

Volume 16, Issue 4

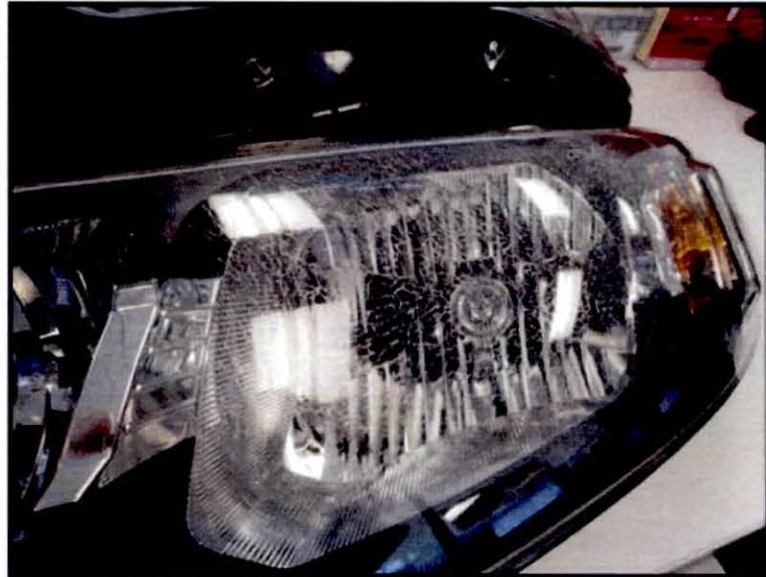
Kia does not recommend the use of harsh solvents or chemical cleaners on headlamp lenses as they may cause, non-warrantable, etching and/or cracking damage. An example of damage from a non-approved cleaner is shown in the image below. The factory recommended procedure is to use only soap and water to clean headlamp lenses.
