# Service Bulletin

<b>Subject:</b>  DRIVER-SIDE POWER DOOR MIRROR VIBRATION	<b>Bulletin No:</b> 09-002/13
	<b>Last Issued:</b> 02/26/2013

2013 CX-5 vehicles with VINs lower than JM3KE\*\*\*\*\*168885 (produced before November 16, 2012)

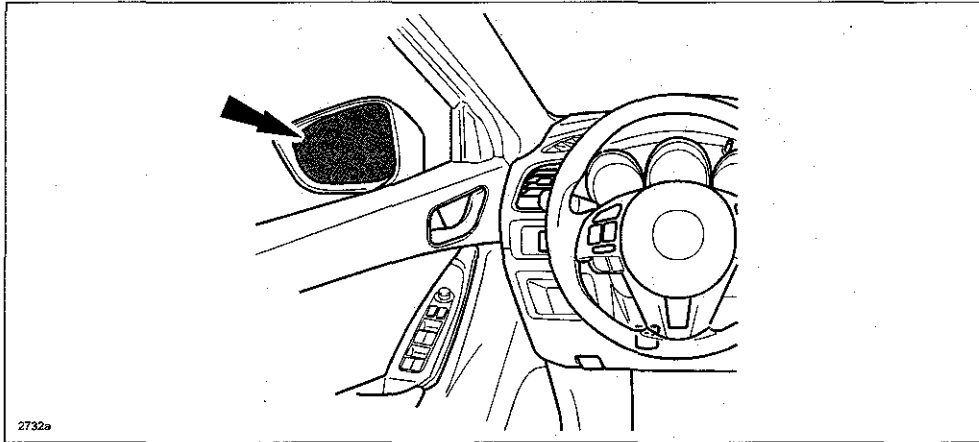
Some vehicles may exhibit a vibration from the driver-side power door mirror glass when the vehicle is driven at high speeds.

This concern may be due to a lack of rigidity of the mirror base so the mirror vibrates when it receives vehicle vibration or wind pressure.

Customers having this concern should have their vehicle repaired using the following repair procedure.
