Subject: TAPPING NOISE WHERE EDGE OF DASHBOARD MEETS WINDSHIELD	Bulletin No: 09-004/13
	Last Issued: 03/06/2013

2013 CX-5 vehicles with VINs JM3KE*****122583 ~ 146712 (produced May 6, 2012 ~ Aug. 31, 2012)

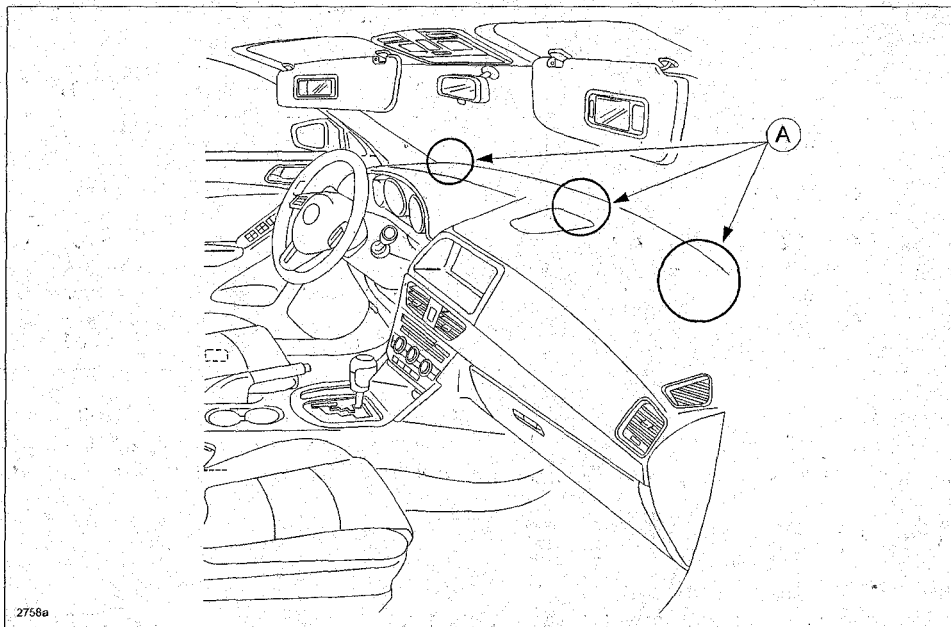
Some vehicles may exhibit a tapping noise which is audible from the front edge of the dashboard (A) (where it meets the base of the windshield) when driving over bumps or rough roads.

The tapping noise may be caused when the front edge of the dashboard contacts the body-side bracket(s). To eliminate the noise, felt pads have been attached to all (3) three body-side brackets during vehicle mass-production.

Customers having this concern should have their vehicle repaired using the following repair procedure.

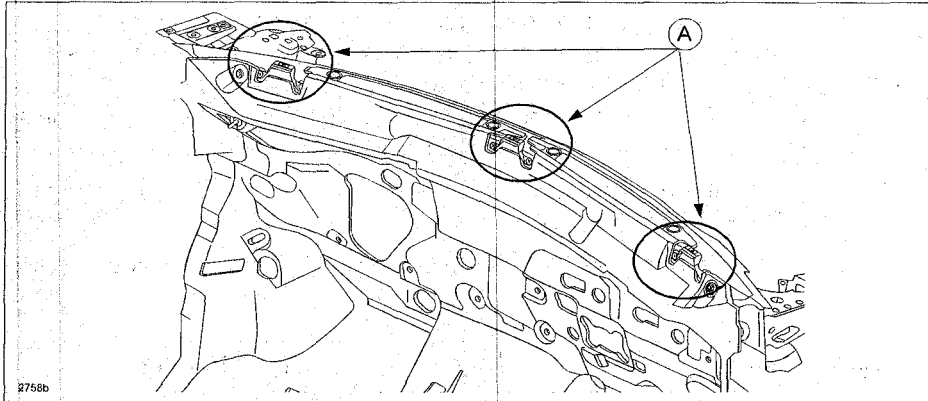
There are (3) three brackets (left, center and right) on the body-side as shown below (A). A felt pad is attached to each bracket for noise prevention. However, depending on the VIN and production date of the vehicle, felt pads may or may not have been attached to all three brackets. Vehicles without felt pads may experience a tapping noise when driving over bumps or rough roads.
