Service Bulletin

Subject: CLICKING NOISE WHEN OPENING TRUNK LID	Bulletin No: 09-006/13
	Last Issued: 03/28/2013

APPLICABLE MODEL(S)/VINS

2014 Mazda6 vehicles with VINs lower than JM1 GJ ***** 109003 (produced before February 01, 2013)

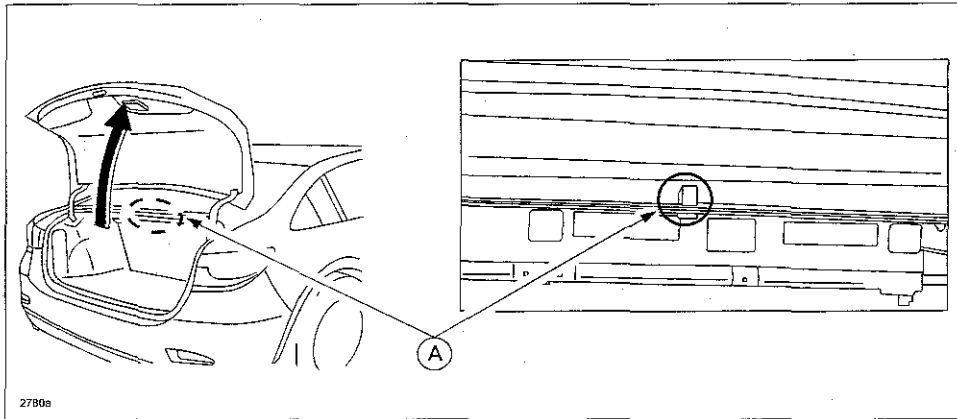
Some vehicles may exhibit a clicking type noise when the trunk lid is fully opened or just before the fully open position. The twisting motion of the trunk lid balance springs (A) may cause the clip fixing the balance springs to move and scrape against the rear package tray panel.

Customers having this concern should have their vehicle repaired using the following repair procedure.
