Service Bulletin

Subject: WIND NOISE FROM REAR DOOR AREA	Bulletin No: 09-007/13
	Last Issued: 03/13/2013

2013 CX-5 vehicles with VINs lower than JM3KE*****140662 (produced July 30, 2012)

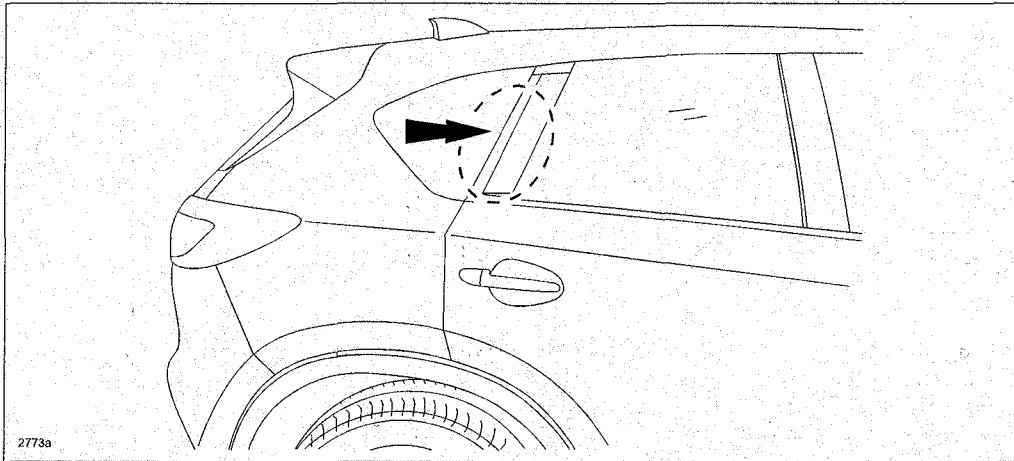
Some vehicles may exhibit wind noise that occurs from the rear door quarter glass while driving at approx. 25 mph (40Km/h). The noise may be caused by a gap between the rear door quarter glass and the rear door garnish. A soft pad has been attached to the rear door quarter glass guide to eliminate the noise.
