<b>Subject:</b>  RATTLE NOISE FROM PASSENGER SIDE DASHBOARD	<b>Bulletin No:</b> 09-008/13
	<b>Last Issued:</b> 03/21/2013

2014 Mazda6 vehicles with VINs lower than JM1 GJ \*\*\*\*\* 109218 (produced before February 4, 2013)

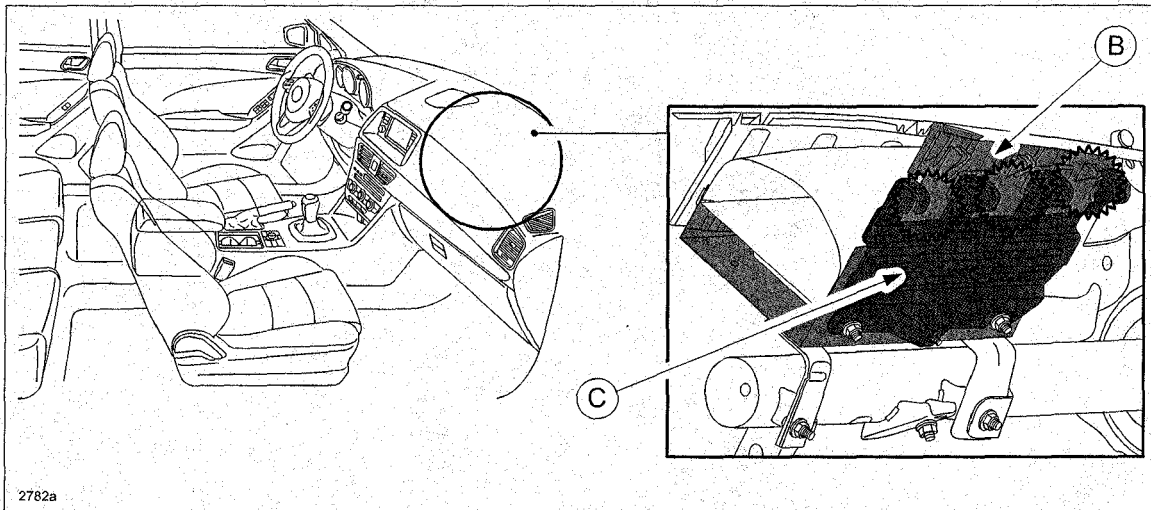
Some vehicles may exhibit a rattle type noise from the passenger side dashboard when driving on a rough road.

This noise may be caused by the passenger-side air bag module bracket (C) contacting the bracket holder (B) when driving on a rough road.

Add non-woven fabric between the passenger-side air bag module bracket and the bracket holder.
