Service Bulletin

DOOR MIRROR BASE COVER DISCOLORATION

2013 CX-5 vehicles with VINs lower than JM3KE*****138997 (produced July 24, 2012)

Bulletin No: 09-009/13	Last Issued: 04/04/2013
© 2013 Mazda Motor of America, Inc.

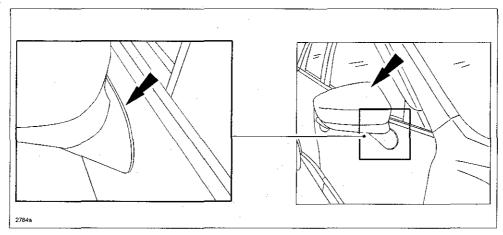
Some vehicles may experience a discoloration (from black to white) of the outer door mirror base cover. The material used for the mirror base cover has been changed to eliminate this concern.

Customers having this concern should have their vehicle repaired using the following repair procedure.
