Service Bulletin

Subject: RATTLE NOISE FROM FRONT DOOR GLASS	Bulletin No: 09-011/13
	Last issued: 04/17/2013

2013-2014 CX-5 vehicles with VINs lower than JM3KE*****300112 (produced before December 28, 2012)

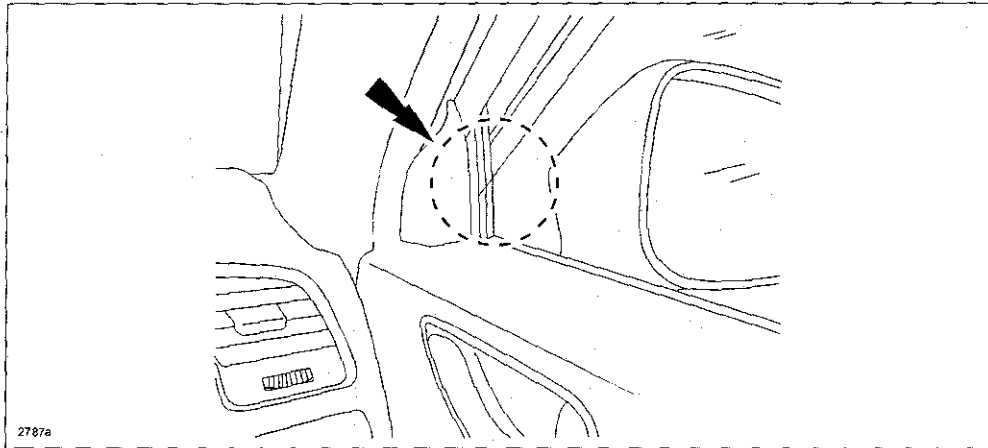
Some vehicles may experience a rattle noise from the front door glass when driving with the window open approx. 1/2 to 4 inches (1 - 10cm).

The rattle noise may be caused by insufficient glass run channel holding force. To eliminate this concern, the shape of glass run channel has been changed in order to increase the holding force.
