<b>Subject:</b>  NOISE FROM FRONT DOOR CHECKER AREA	<b>Bulletin No:</b> 09-012/13
	<b>Last Issued:</b> 04/29/2013

2013-2014 CX-5

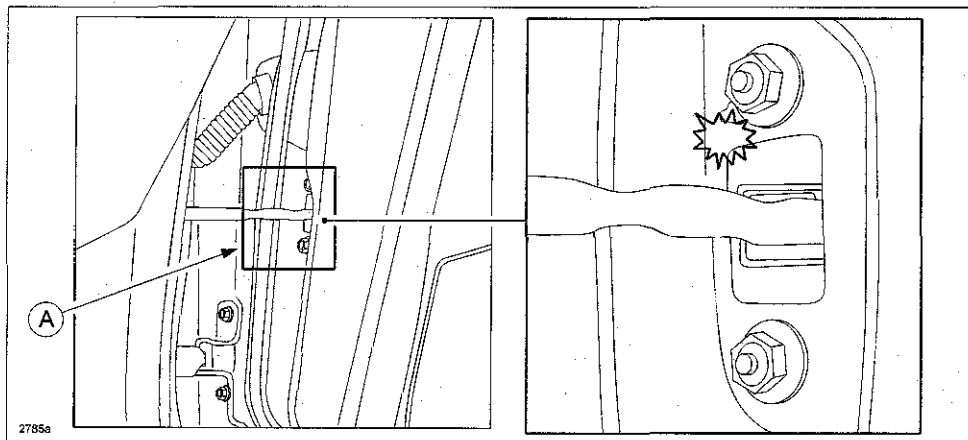
Some vehicles may experience noise from the front door checker installation location (A) whenever the door is opened. When the door is fully opened, the door checker may become over-stroked and cause a crack at the spot welding area around the door checker.

Customers having this concern should have their vehicle repaired using the following repair procedure.

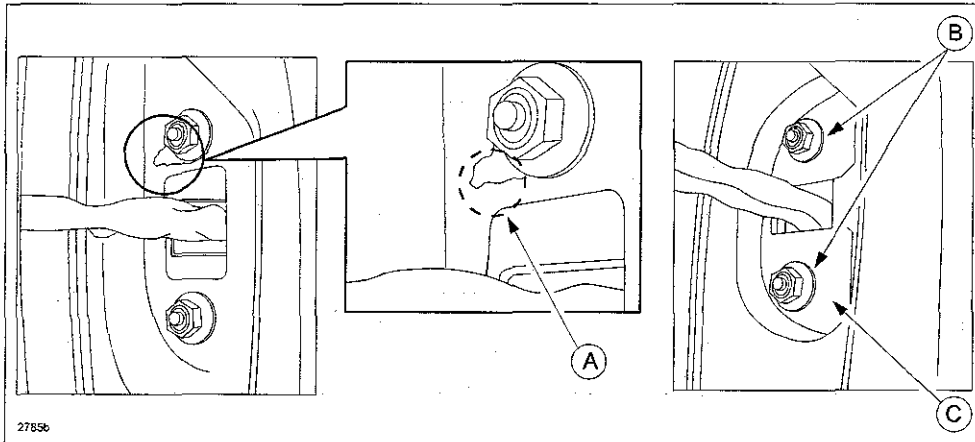
1. Verify the customer concern.
2. Inspect the body panel welding point (A) on both front doors.
  - If no cracks are found on the body panel, this service bulletin does not apply. Refer to the online instructions on MS3 or the Workshop Manual (Section 09 - Body and Accessories) for further troubleshooting.
  - If the body panel is cracked, repair it according to the steps below:

- a. Apply approx. 0.3 ml grease per side (using either molybdenum grease or lithium grease) on the welding point (A) (cracked area).
- b. Install plate (C) (checker reinforcement) on the body panel.  
**Tightening Torque (B): 71-106 in·lbf {8-12 N·m, 82-122 kgf·cm}**
- c. Repeat the repair on opposite side front door.

- a. Remove all corrosion found on the body panel.
  - b. Apply primer to the repaired surface.
  - c. Apply touch up paint to the repaired surface.
  - d. Install plate (C) (checker reinforcement) on the body panel.  
**Tightening Torque (B): 71-106 in·lbf {8-12 N·m, 82-122 kgf·cm}**
  - e. Repeat the repair on opposite side front door.
3. Verify repair.
