# Service Bulletin

| <b>Subject:</b><br><b>UNABLE TO LOWER REAR SEATBACK WITH REMOTE HANDLE / SEATS HARD TO LOCK</b> | <b>Bulletin No:</b> 09-013/13<br><b>Last Issued:</b> 10/24/2013 |

2013-2014 CX-5 vehicles equipped with a 4:2:4 split type rear seat

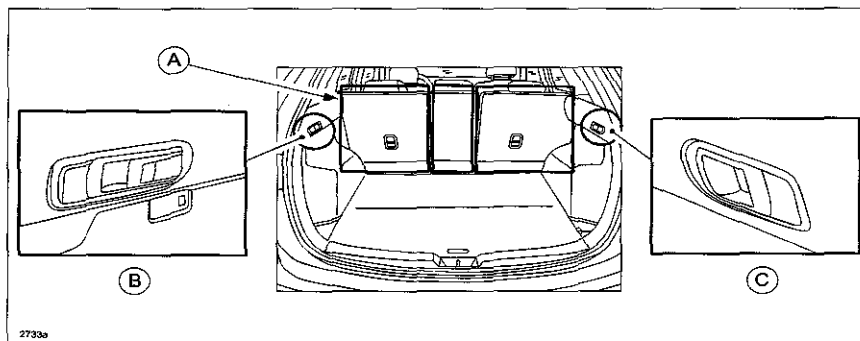
Some vehicles equipped with a 4:2:4 split type rear seat may be unable to lower the rear seatback (A) when pulling the left (B) and/or right (C) remote handles. Also, the seatbacks may not fully latch (lock) when placed in the upright position.

3. Replace the remote handle lever assembly (including the remote cable) according to the online MS3 instruction or the Workshop Manual (section 09-13 REMOTE HANDLE LEVER REMOVAL/INSTALLATION).

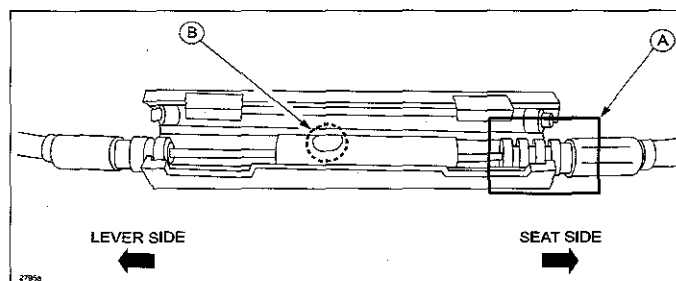
This concern may be caused by either of the following:

- Insufficient remote cable tension due to incorrect adjustment position (A) of the remote cable.
- The cable ball (B) gets seized on sharp edges inside the cylinder.

4. Set the adjustment groove to the position where the malfunction does not occur according to the online MS3 instruction or the Workshop Manual (section 09-13 REAR SEAT REMOVAL/INSTALLATION - Remote Cable Adjustment Procedure).

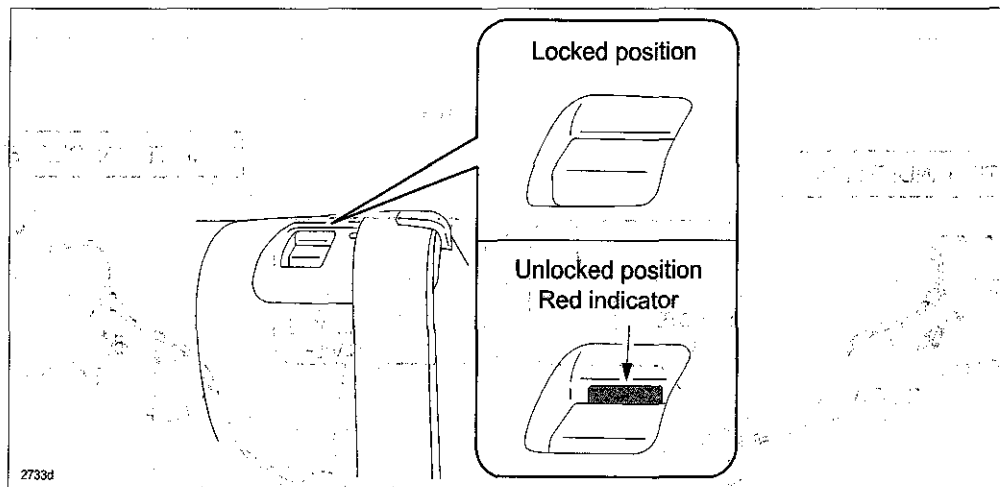
**NOTE:** The red seat knob indicator must be visible when the seat back is in the unlocked position (seat knob down) and must not be visible when the seat is fully locked (seat knob up).

5. Verify the repair by pulling the appropriate remote handle lever to check the seat back for proper releasing and locking operation.
