Subject: UNABLE TO LOWER REAR SEATBACK WITH REMOTE HANDLE / SEATS HARD TO LOCK	Bulletin No: 09-013/13
	Last Issued: 04/29/2013

2013-2014 CX-5 vehicles equipped with a 4:2:4 split type rear seat with VINs lower than JM3KE*****318331 (produced before Feb. 1, 2013)

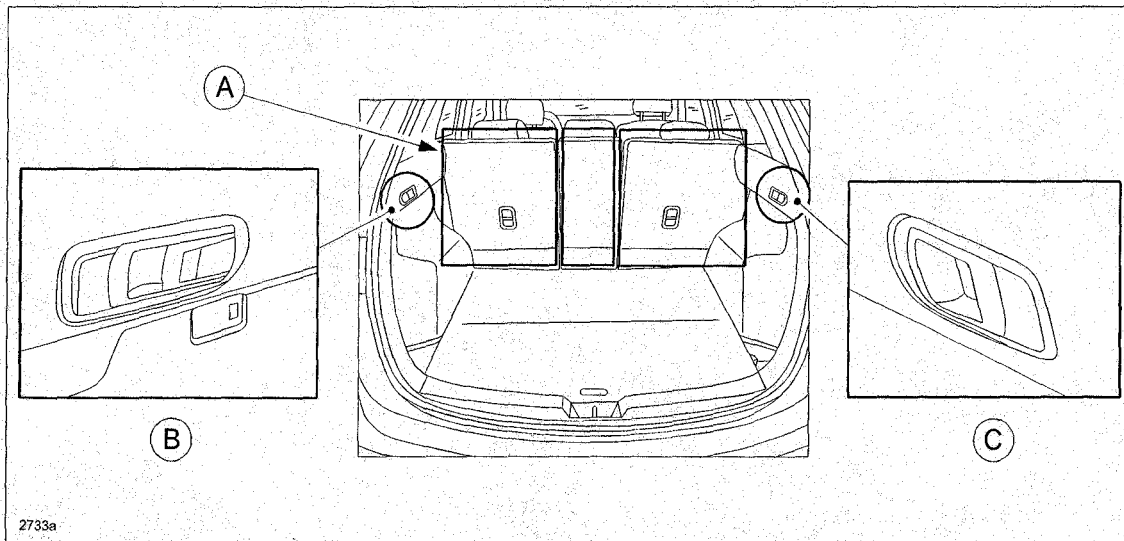
Some vehicles equipped with a 4:2:4 split type rear seat may be unable to lower the rear seatback (A) when pulling the left (B) and/or right (C) remote handles. Also, the seatbacks may not fully latch (lock) when placed in the upright position.

This concern may be caused by an incorrect seatback remote cable adjustment position. The current adjustment position may not provide enough tension for the cable to unlock the seatback latches.

The position of the seatback remote cable adjustment has been changed to the center position at mass-production.

Customers with this concern should have their vehicle repaired according to the following repair information.

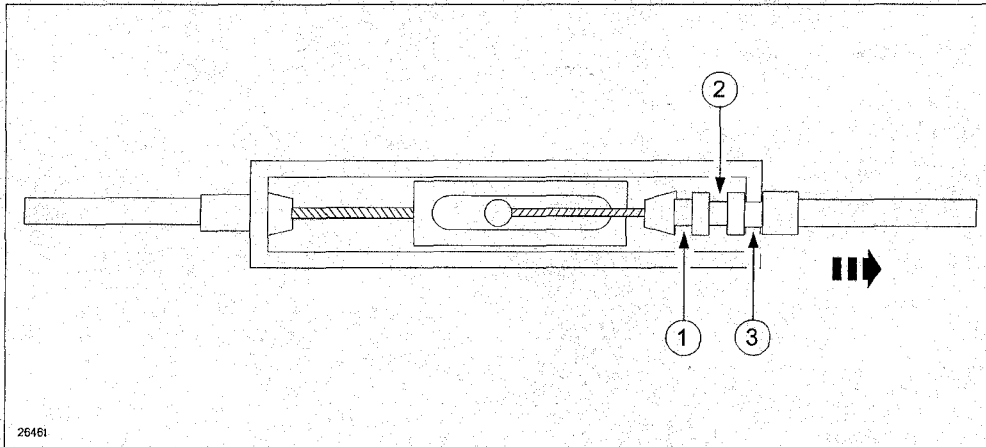
NOTE: Cable adjustment setting position "3" is the factory setting for vehicle produced before Feb. 1, 2013.

- Using a small flathead screwdriver, pop open the affected remote cable adjuster housing and check the current cable adjustment setting position (1, 2 or 3) as shown below.

- Pull the cable out of the housing and change the setting to position "2", then snap the remote cable adjuster housing closed.
- Using the appropriate remote handle lever, check the seat back for proper releasing and locking operation.
