Subject: SUNROOF WATER LEAK AFTER HIGH PRESSURE CAR WASH	Bulletin No: 09-014/13
	Last Issued: 05/03/2013

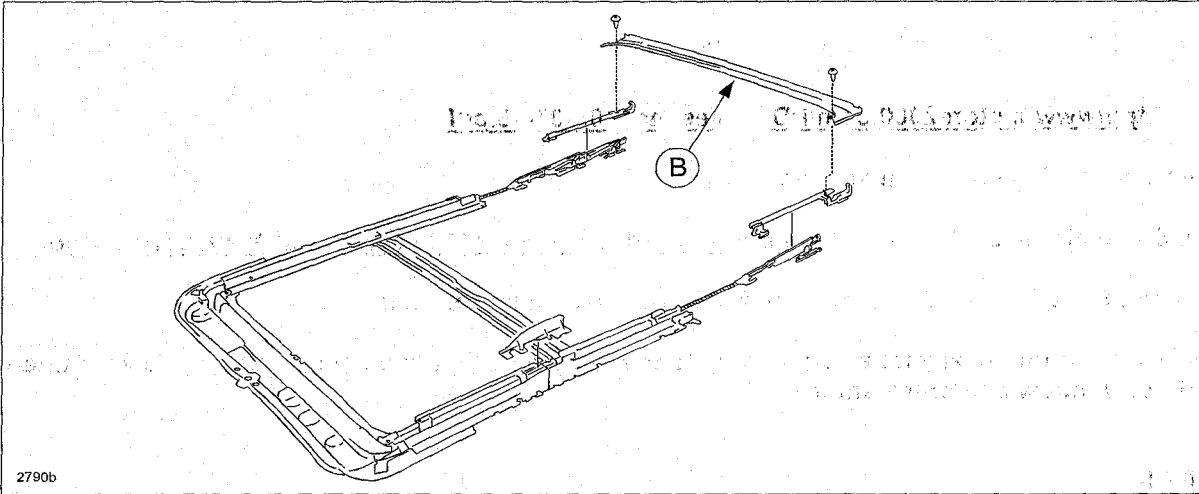
Some customers may experience a water leak from the sunroof after washing the vehicle with a high-pressure car wash system. High pressure water from the car wash may drip from the drip rail and leak into the cabin.

3. Replace the drip rail (B). Refer to MS3 online or Workshop Manual:
 - Mazda6 - (section 09-15 SUNROOF UNIT DISASSEMBLY/ASSEMBLY).
 - CX-5 - (section 09-15 SUNROOF UNIT DISASSEMBLY/ASSEMBLY).
 - CX-9 - (section 09-15 SUNROOF UNIT DISASSEMBLY/ASSEMBLY).
