Subject: TOMTOM NAVIGATION SYSTEM SERVICE INFORMATION	Bulletin No: 09-015/13
	Last Issued: 05/07/2013

M-TIPS

UNIQUE REPAIR INFORMATION FOR
MAZDA TECHNICIANS

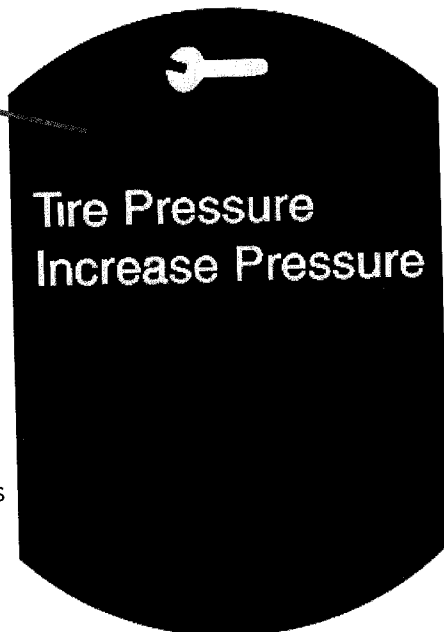
Tire Pressure Maintenance Display

Some customers may complain about a TPMS malfunction when they see the "Tire Pressure Increase Pressure" message displayed in the Instrument Cluster Multi-Information Display. This message is a preset service reminder to check the tire air pressures. **It is not a low tire pressure warning or a TPMS malfunction.**

The Maintenance Monitor may have been turned ON during PDI without the customer's knowledge; consequently, when the preset time period elapsed, the customer could misinterpret the message as a TPMS malfunction.

1. Use the steering wheel INFO switch to navigate to the "Maintenance" section of the Multi-Information Display.
2. Select "Tire Pressure"
3. Select "Set Time"
4. Set new values (if current values are being reused, skip to the next step)
5. Press the INFO button

1. Use the steering wheel INFO switch to navigate to the "Maintenance" section of the Multi-Information Display.
2. Select "Tire Pressure"
3. Select OFF

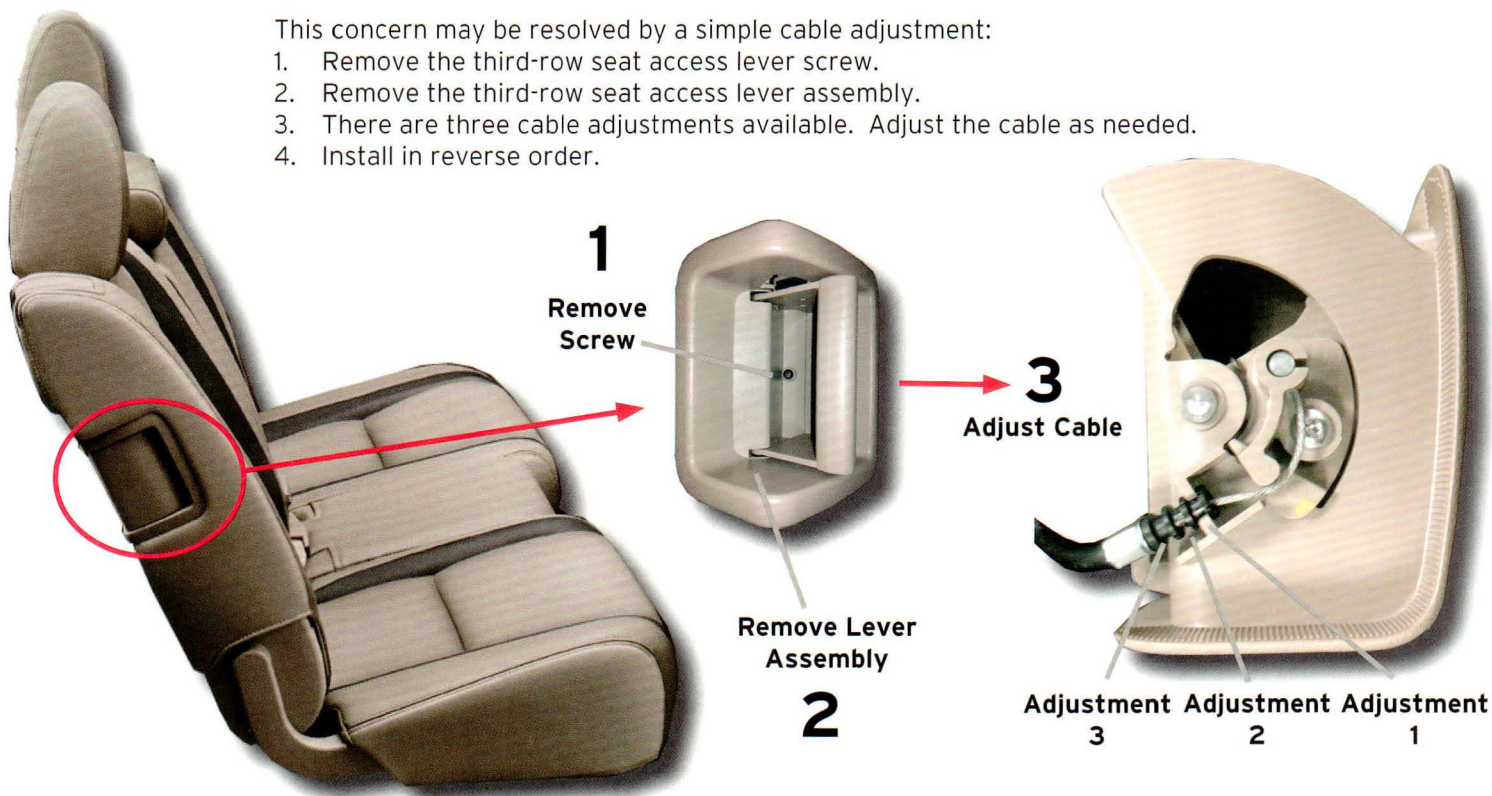
THIRD-ROW SEAT ACCESS LEVER INOPERATIVE

Some customers may complain about a third-row seat that is difficult to fold. This may be caused by a third-row seat access lever that is out of adjustment.

This concern may be resolved by a simple cable adjustment:

1. Remove the third-row seat access lever screw.
2. Remove the third-row seat access lever assembly.
3. There are three cable adjustments available. Adjust the cable as needed.
4. Install in reverse order.

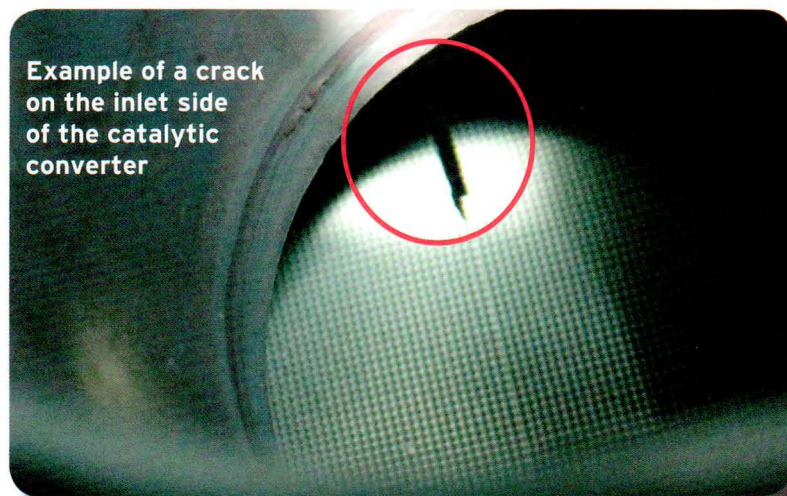
MIL ON WITH DTC P0139 OR P013A

Some customers may complain about an MIL ON with the following DTC stored in memory:

- CX-7 - P0139 (HO2S circuit slow response)
- CX-9 - P013A (HO2S (RH) slow response-rich to lean)

This may be caused by an internally cracked catalytic converter.

Note: The catalytic converter failure may have been caused by another concern. Catalyst replacement without correcting the root cause may damage the new catalytic converter.

If Workshop Manual diagnosis does not resolve the concern, remove the catalytic converter (for CX-9, remove the RH) and inspect the inlet side for cracks. Replace the catalytic converter if an internal crack is found.

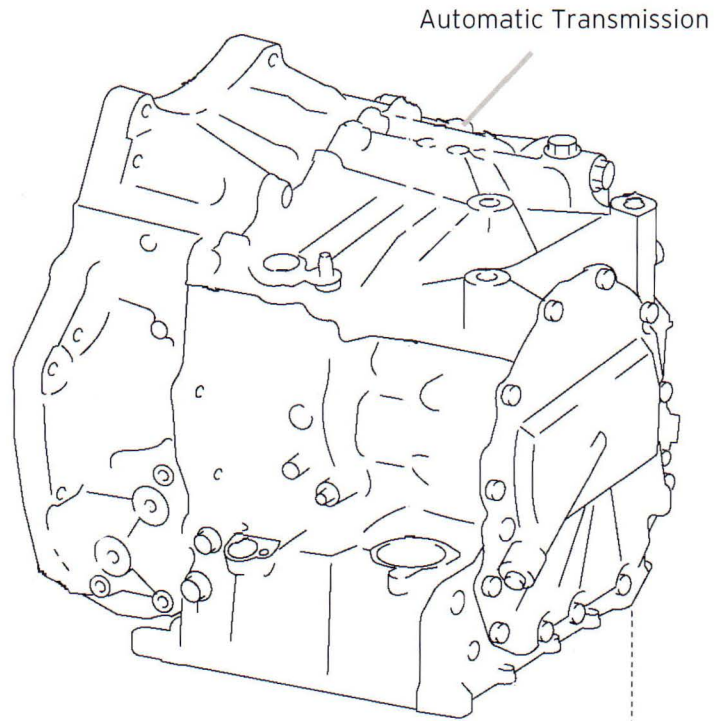
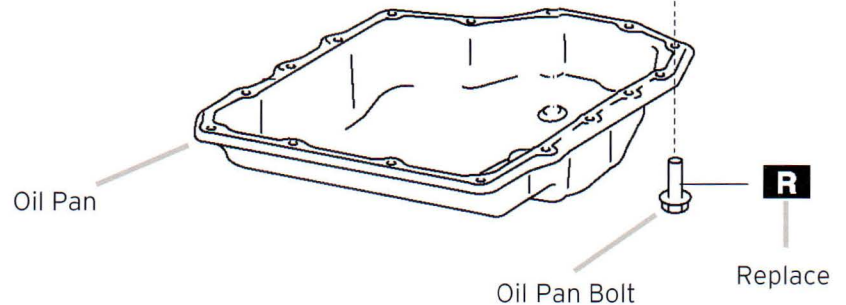
MULTI-MODEL AUTOMATIC TRANSMISSION OIL PAN BOLTS

If an automatic transmission oil pan removal is necessary on a transmission listed below, an engineering change has taken place. The automatic transmission oil pan bolts (P/N 9YA0-10-615A) cannot be reused. Install new bolts when installing the oil pan.

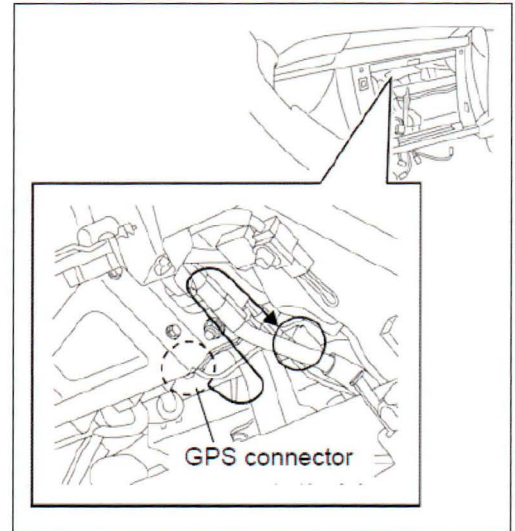
GPS connection installation amendment

Accessory Navigation system is inoperative after installation

The Genuine Mazda Accessory Navigation installation instructions have been amended with a new GPS connection procedure for the 2014 model year. Failure to use this new procedure (shown below) will cause an inoperative Navigation system after installation.

1. Disconnect the connector from the unit and connect it to the connector as shown.
2. Install the glove compartment in the reverse order of removal.

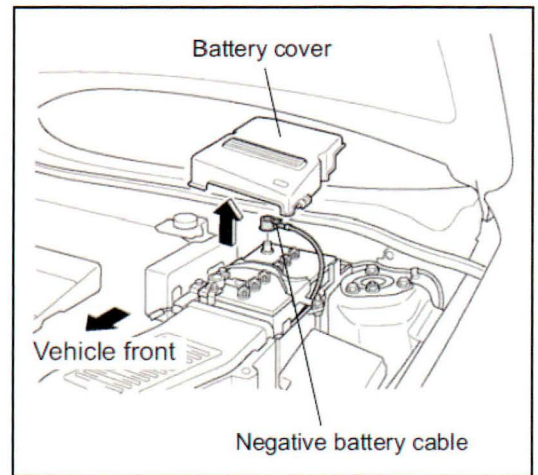
Negative battery cable disconnection

Accessory Satellite Radio is inoperative after installation

If the battery negative cable is not disconnected per instruction, the CAN system will not recognize the new accessory. This will result in an inoperative satellite radio after installation. Follow the first two steps in the instructions as shown below:

1. Set the selector lever to "P" range (AT vehicles only).
2. Disconnect the negative battery cable and wrap tape around it to insulate.
