Subject: POWER LIFTGATE CLOSING BUT DOES NOT LATCH COMPLETELY	Bulletin No: 09-017/13
	Last Issued: 05/28/2013

2007-2013 CX-9 vehicles with VINs lower than JM3 TB ***** 418826 (produced before April 4, 2013)

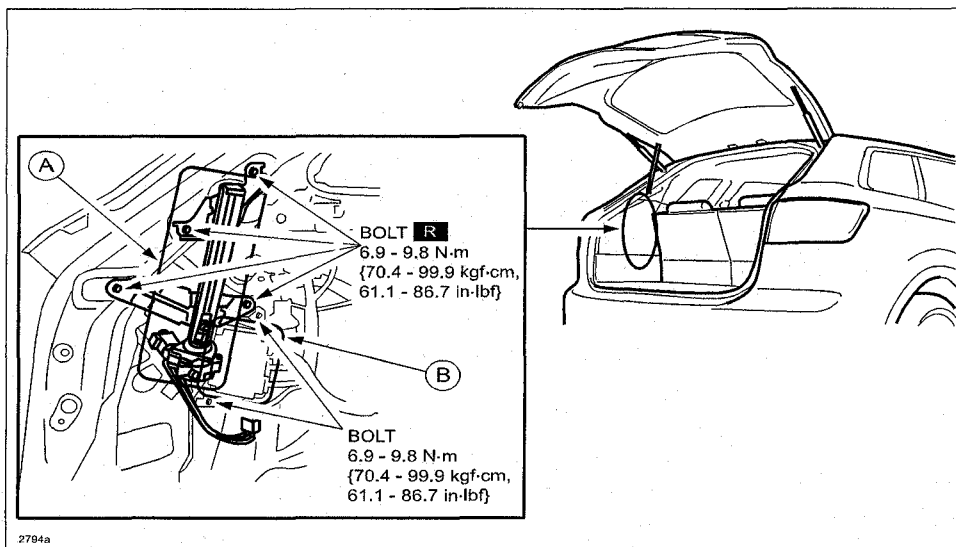
Some customers may experience a power liftgate (PLG) that closes but does not latch completely when the PLG button is pressed.

1. Verify customer concern.
2. Disconnect the negative battery cable.
3. Replace the PLG driver and PLG slider (A). Refer to MS3 online or Workshop Manual:
 - PLG driver - section 09-11 POWER LIFTGATE (PLG) DRIVE UNIT REMOVAL/INSTALLATION
 - PLG slider - section 09-11 POWER LIFTGATE (PLG) SLIDER REMOVAL/INSTALLATION

NOTE: Install with 4 new bolts and torque them to 61.1 - 86.7 in-lbf (70.4 - 99.9 kgf-cm).

4. Replace the PLG control module (B). Refer to MS3 online or Workshop Manual (section 09-11 POWER LIFTGATE (PLG) CONTROL MODULE REMOVAL/INSTALLATION).

NOTE: Install with 2 new bolts and torque them to 61.1 - 86.7 in-lbf (70.4 - 99.9 kgf-cm).
