Subject: DRIVER SIDE SEATBACK RECLINING POSITION CHANGES BY ITSELF WHEN CUSTOMER EXITS THE VEHICLE	Bulletin No: 09-020/13
	Last Issued: 09/05/2013

2013-2014 CX-5 vehicles equipped with power seats, with VINs lower than JM3 KE***** 338025 (produced April 1, 2013)

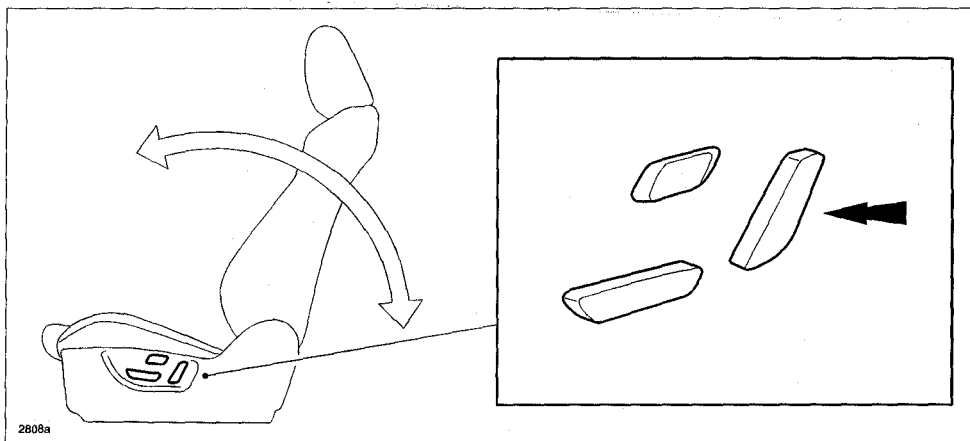
Some customers may complain that the driver side seatback reclining position seems to change by itself. This may be caused unknowingly by the customer when they exit the vehicle. The customer's leg may be contacting the recliner switch knob and changing the seatback reclining position.

The configuration of the recliner switch knob has been changed to eliminate this concern. Customers having this concern should have their vehicle repaired using the following repair procedure.

1. Verify the customer concern.
2. Replace the recliner switch knob with a modified new part according to the instructions on MS3 online or the Workshop Manual (section 09-13 FRONT SEAT SIDE COVER REMOVAL/INSTALLATION).
3. Verify the repair.
