Subject: EXCESSIVE OPERATING NOISE WHEN SLIDING POWER SEAT	Bulletin No: 09-021/13
	Last Issued: 07/19/2013

2014 Mazda6 equipped with power seats with VINs lower than JM1GJ*****125980 (produced June 1, 2013)

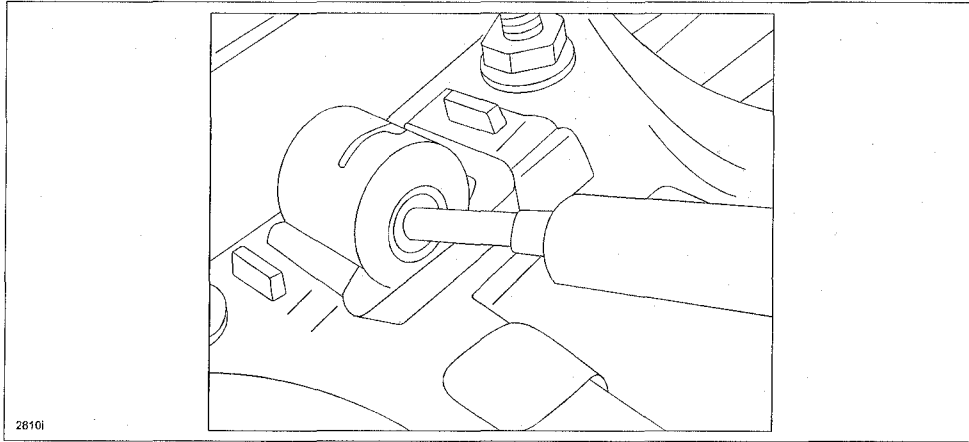
- If the cable is bent too much during installation, operation noise may occur. DO NOT hold the cable around the tip.

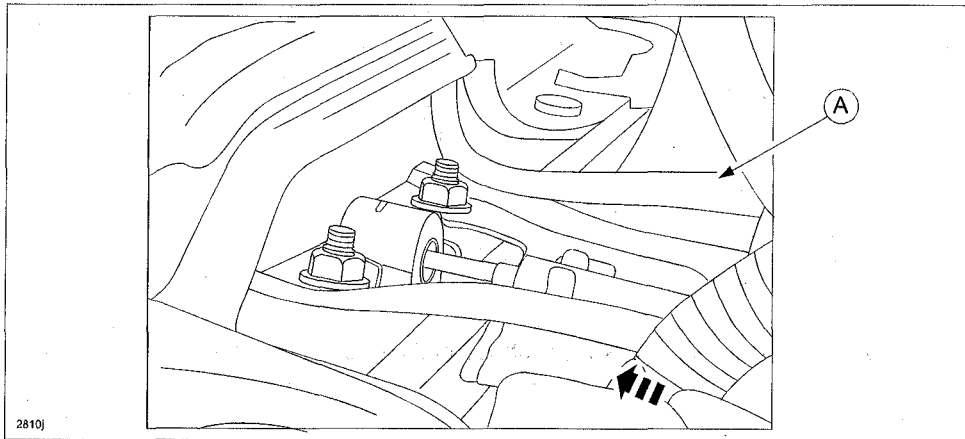
- If work space is too dark to see properly, use a light to illuminate the spot where the cable should be installed.
- Take caution not to pinch the seat belt buckle harness (A).

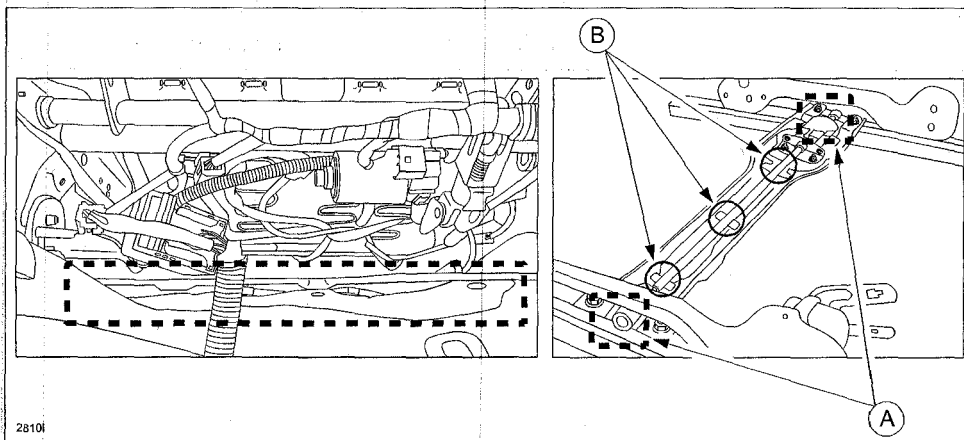
- The cable is not curved or floating.
- The cable is properly installed into the motor side and gear box side (A).
- The cable is properly secured to the seat frame at each cable bracket (B).

14. Look under the seat and verify the following points:

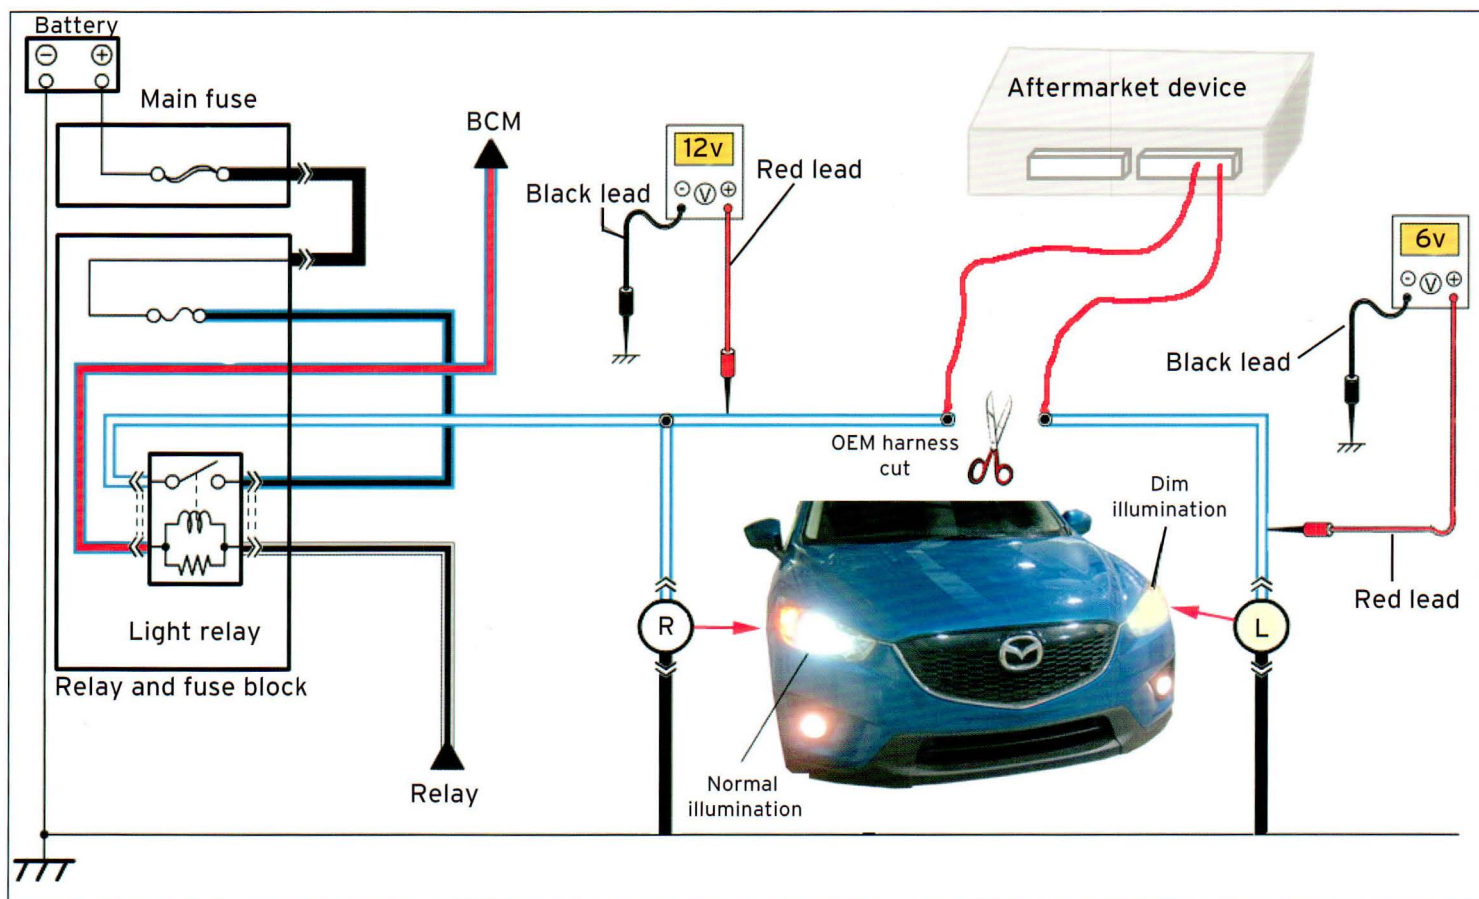
Some aftermarket devices that are wired to the vehicles's wiring harness may create unusual electrical symptoms and/or store DTCs. Below is an example of a dim headlight. The aftermarket device changed the headlight circuit resistance, causing a dim headlight.

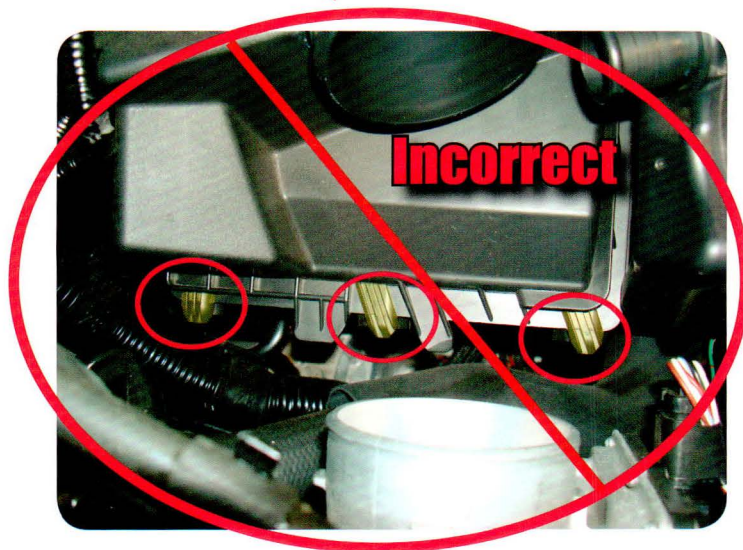
Incorrect

Left side of the air cleaner cover is not inserted into the lower air cleaner housing correctly.

When replacing or inspecting the air cleaner element, make sure the air cleaner cover is properly secured to the lower air box. Some air cleaner covers have 3 inserts on one side and 2 anchors on the other side. A MIL may be stored and/or a rough idle may occur if the air cleaner cover is not installed correctly.

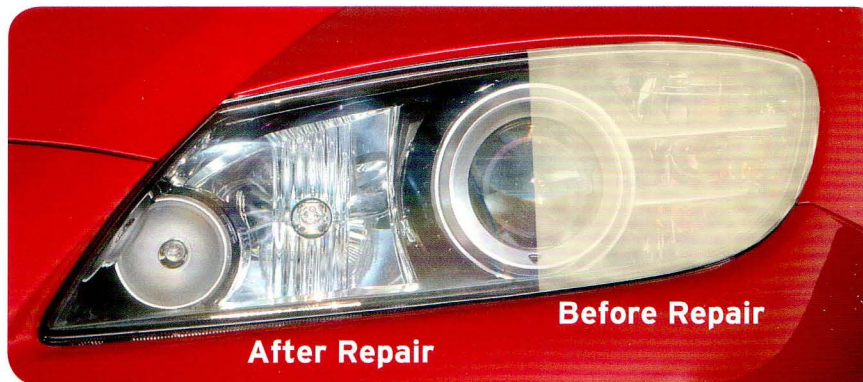
The headlight lens discoloration or cloudiness is a problem plaguing the automotive industry. Varying degrees of this condition can be found on vehicles 4 years or older, regardless of vehicle make or model. The problem is caused by ultraviolet (UV). This degradation of the original hardcoat on the lens. This exposes the unprotected polycarbonate surface, which quickly yellows and turns cloudy.

To correct this concern and provide a long term solution, Mazda has approved the Presta ReNuLite® Headlight Restoration Kit. This Kit has three distinct advantages over similar repair products found on the market today.

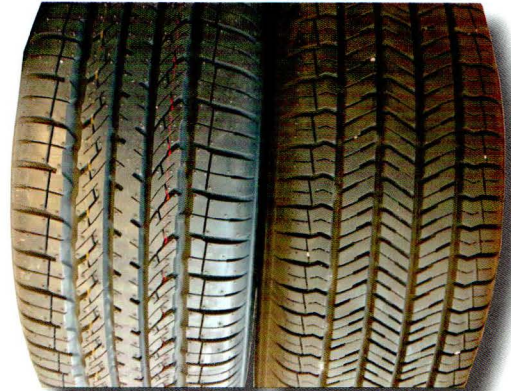
Tire tread pattern mismatch

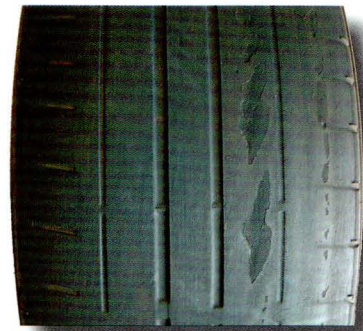
Tire worn

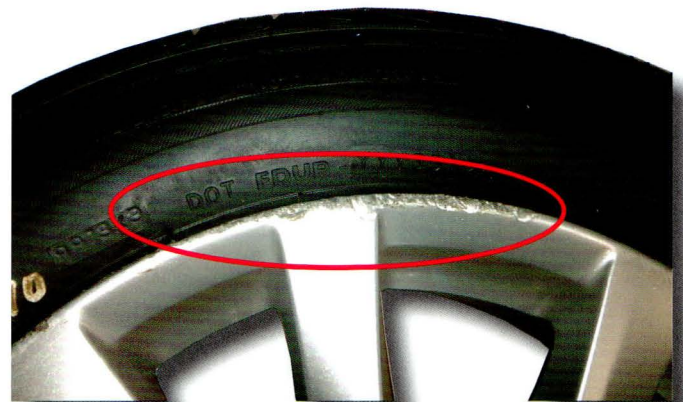
Wheel damage

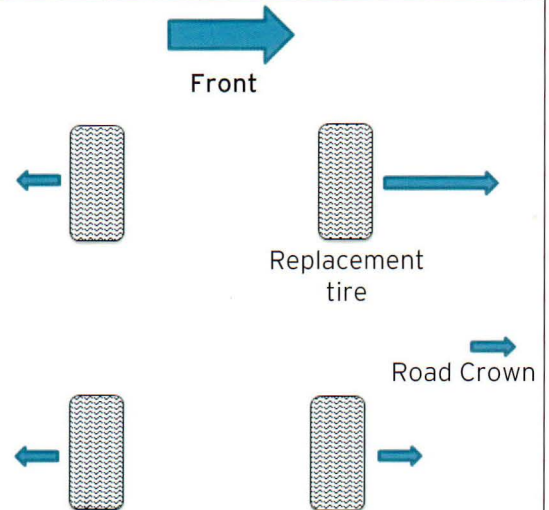
Correct Tire Installation with Pull/Drift

All tires are installed correctly with the indicators facing outward. The replacement tire conicity lateral force is sometimes more than the three other tires on the vehicle. This additional lateral force, plus road crown, may cause the vehicle to pull/drift to the right when driven.
