Subject: RATTLE / VIBRATION NOISE FROM RIGHT REAR OF VEHICLE	Bulletin No: 09-022/13
	Last Issued: 07/31/2013

2013 CX-5 vehicles equipped with theft-deterrent with VINs lower than JM3 KE***** 169135 (produced November 19, 2012)

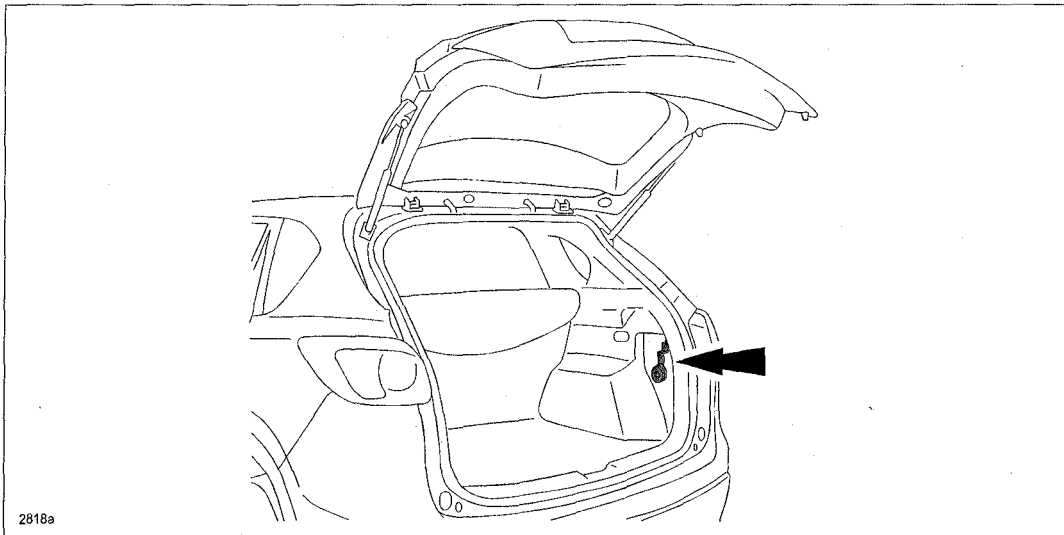
The noise may be caused by vibration from the theft-deterrent horn bracket.

An EPT sealer has been attached to the theft deterrent horn during mass-production to eliminate the noise. Customers having this concern should have their vehicle repaired using the following repair procedure.
