Service Bulletin

Subject: REAR DOOR WILL NOT OPEN	Bulletin No: 09-023/13
	Last Issued: 08/13/2013

2014 Mazda6 vehicles with VINs lower than JM1 GJ ***** 119979 (produced before April 9, 2013)

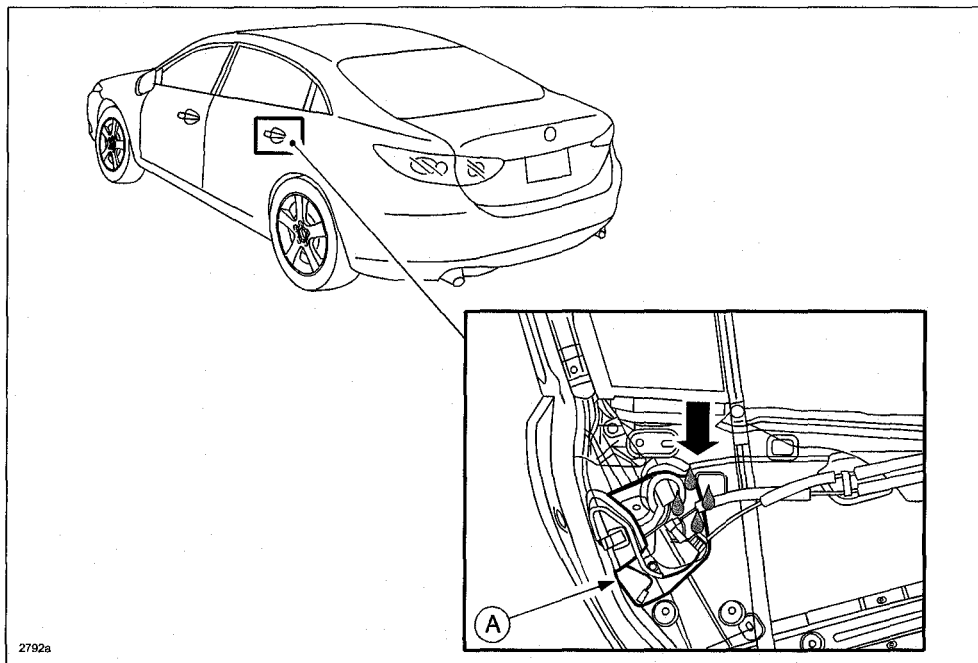
When the ambient temperature drops below 32 degrees Fahrenheit (0 degrees Celsius), especially after rain or car wash, some customers may experience a rear door(s) that will not open. This may be caused by water entering the inside of the rear door latch and lock actuator (A) and then freezing at low temperatures.

Customers having this concern should have their vehicle repaired using the following repair procedure.
