# Service Bulletin

<b>Subject:</b>  DOOR TRIM ARM REST SURFACE PEELING	<b>Bulletin No:</b> 09-024/13
	<b>Last Issued:</b> 09/17/2013

2010-2012 CX-7

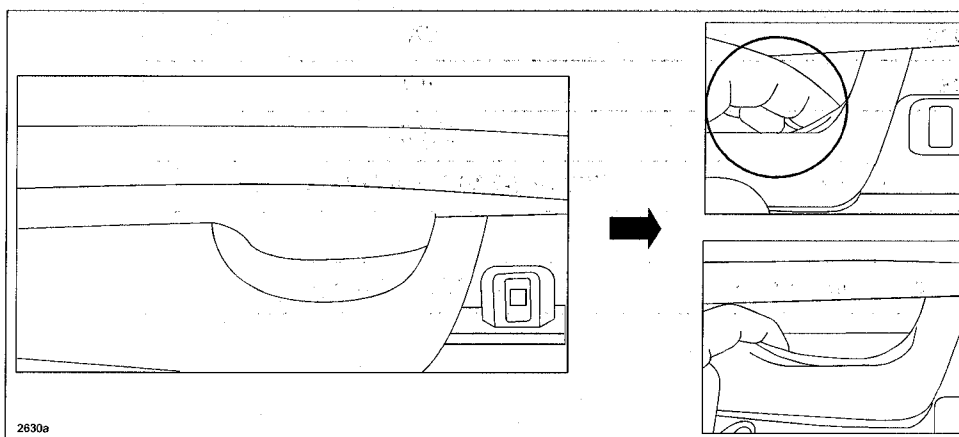
On some vehicles, the surface of the door trim arm rest may peel off, resulting in poor appearance. This may be caused by poor adhesion. The surface may peel when the arm rest is grabbed by hand.

As a mass-production improvement, additional adhesion has been applied to the arm rest surface.

Customers having this concern should have their vehicle repaired using the following repair procedure.
